Client Information: Record Number 20091103b

**Home, Buyer**  
**City Lane**  
**Chicago, IL**

Inspected 11/3/09 1:00 PM

# Inspection Summary

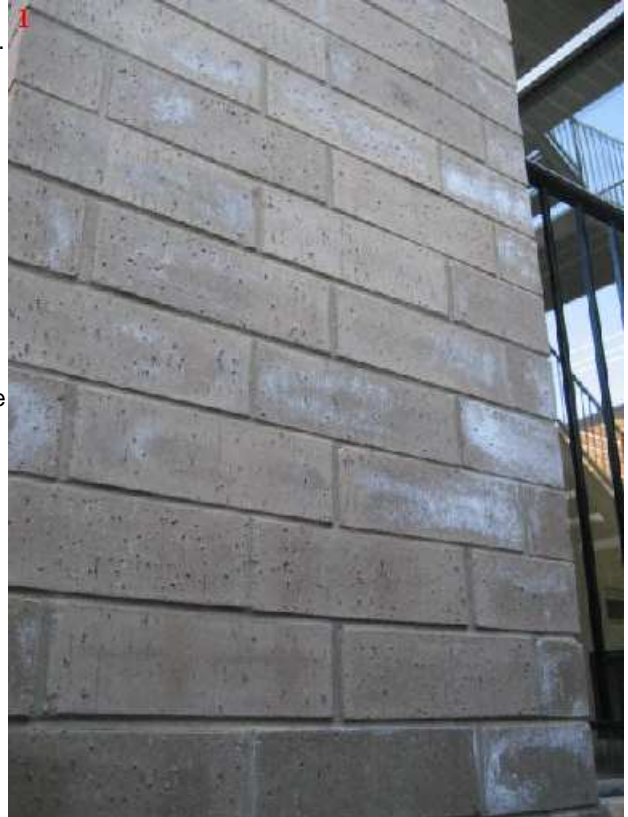
- Consult with a qualified mason to address the following issues:
- The lintels need another coat of paint to prevent them from rusting. Scrape and remove existing rust, then re-paint.
  - Efflorescence (white mineral deposit that occurs when masonry products and water mix) is noted throughout the brick walls and columns. In a new construction building we cannot determine if this is because too much water is getting into the masonry due to construction problems or if it is because the bricks were wet on the construction site and are now drying out. We recommend a light acid wash to remove the existing efflorescence. Then monitor the building for development of new efflorescence. Photo shows example.
  - Repair the broken masonry around the SW corner water spigot head.
  - Remove the spray paint on the bricks in the NE corner of the home on the east wall.

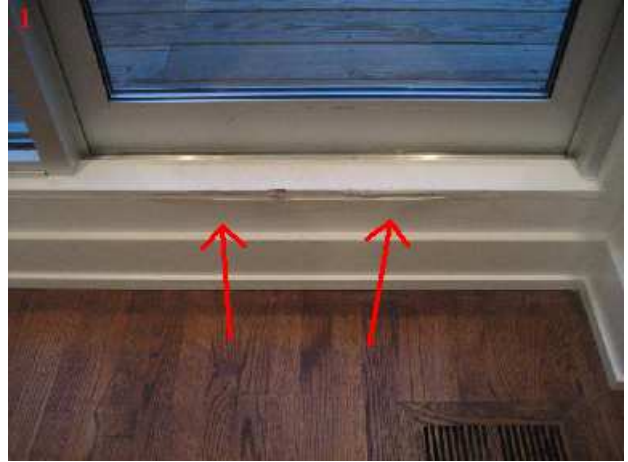
The roof deck door (south) is leaking at the base. The area was tested with a moisture meter and was wet at the time of the inspection. Please check door flashings/installation and repair as necessary to stop all leaking. See photo

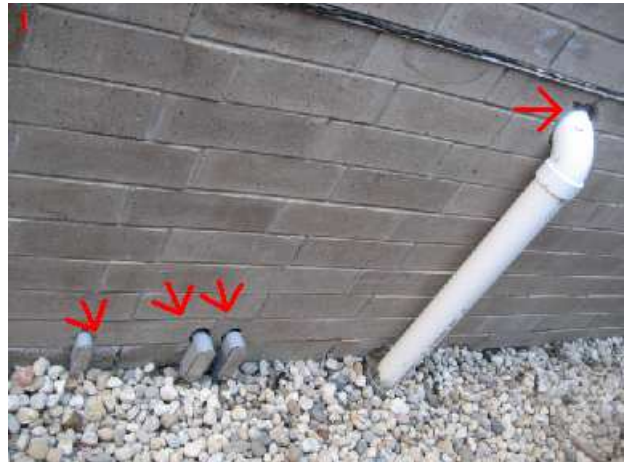
Please add caulking where the electrical lines leave the main home to go to the garage and around the opening for the back deck drain.

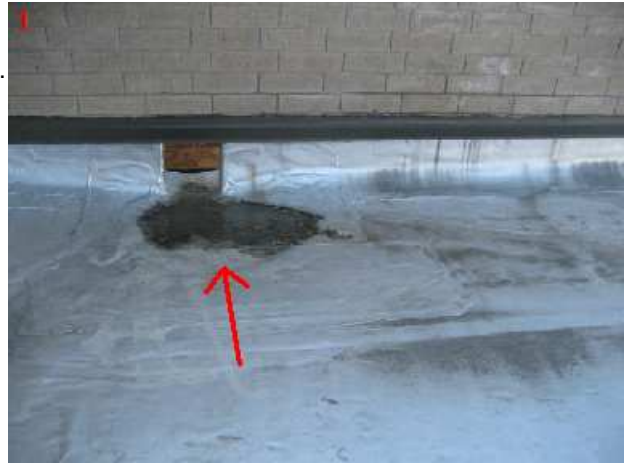
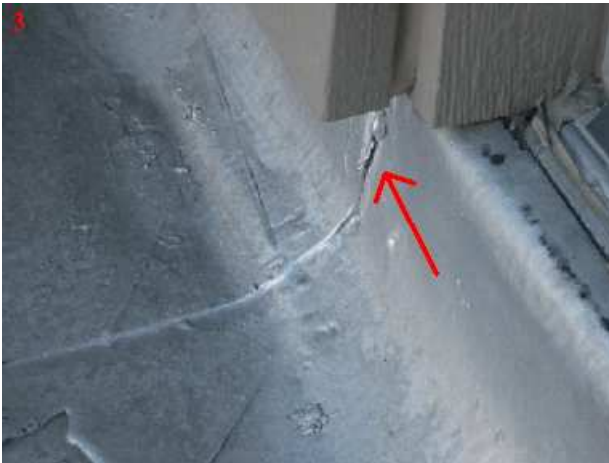
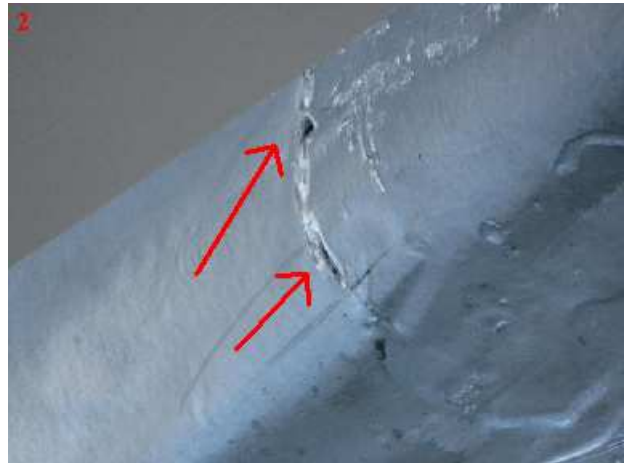
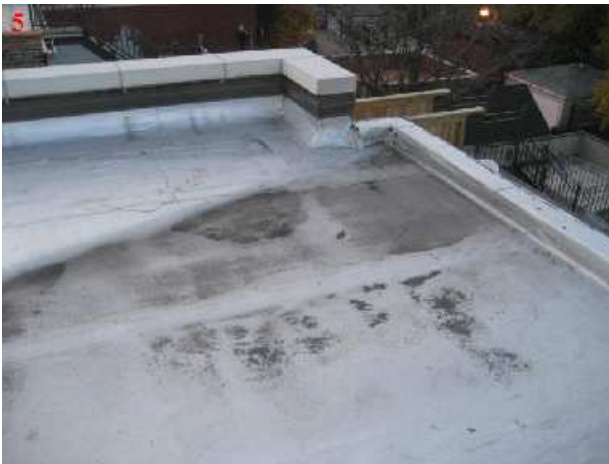
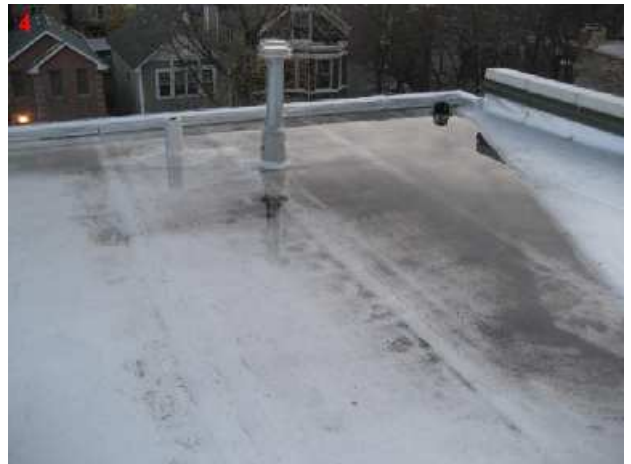
### Service/Repair Condition - Repair seams

- Re-seal all gaps in the seams on the roof (photos show examples). During the freeze/thaw cycle, water will get trapped in these gaps and will eventually cause leaking in these areas. Photos 2/3
- Water is ponding in front of the scupper on the back roof deck. Re-pitch this area so that water drains completely into the scupper. Photo 1
- Recommend rolling the roofing material into all scuppers and around the edges of the drain area as opposed to terminating the material at the edge of the scuppers.
- There is a significant amount of ponding water on the top section of the roof (photos 4/5). Re-pitch this roof so that water drains completely into the drain.

Please consult with a qualified roofer to address the following issues:

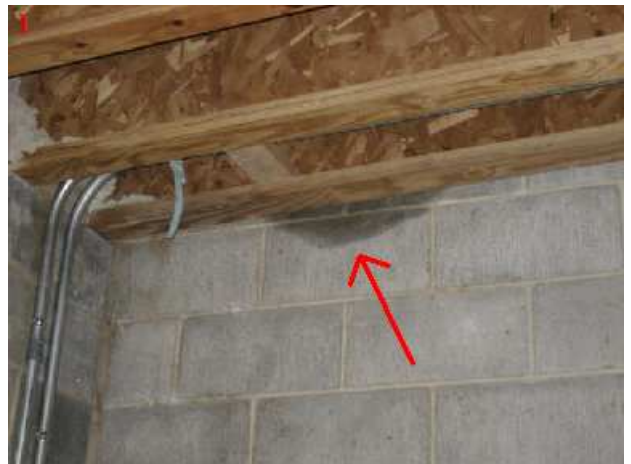
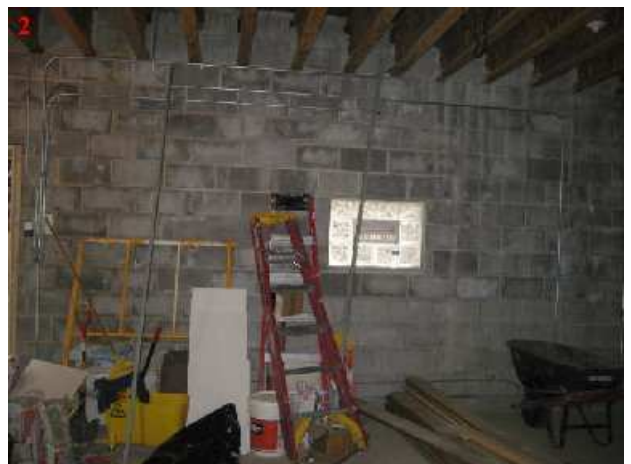
There is a water stain in the upper SW corner of the garage. It appears that water is leaking from the roof but this area is covered by decking. Recommend further evaluation and repair.

There is evidence of water throughout the south and north garage interior walls. We cannot determine if this is from exterior leaking or because the blocks are drying out. Please clean walls with an acid wash and monitor.

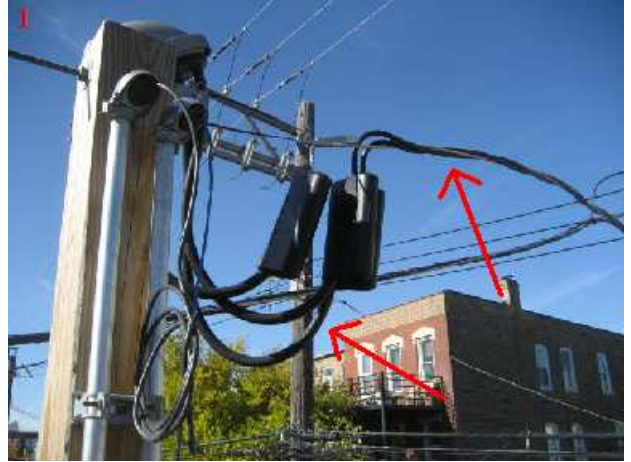
The main wires from the pole appear to be 200-amp wires. The wiring in the panel is for a 400-amp service. Please consult with ComEd to determine if the exterior wiring needs to be upgraded.

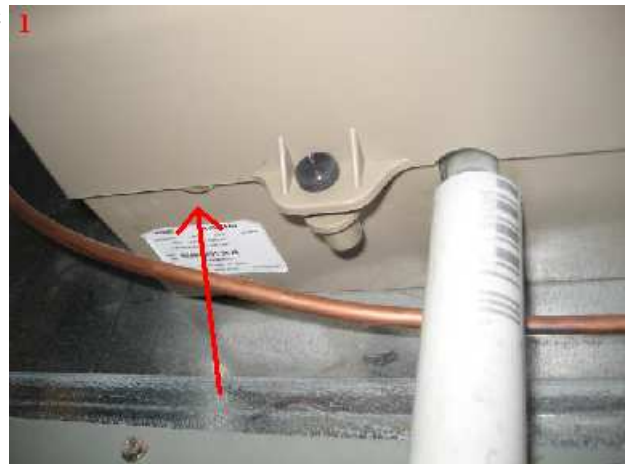
The humidifier is leaking. Please have repaired by a licensed HVAC contractor. Basement

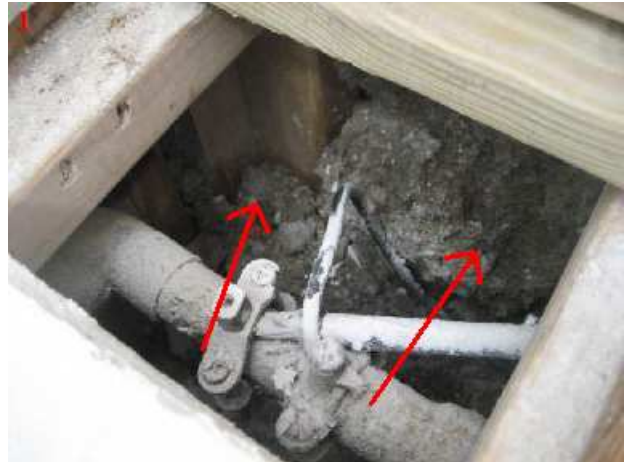
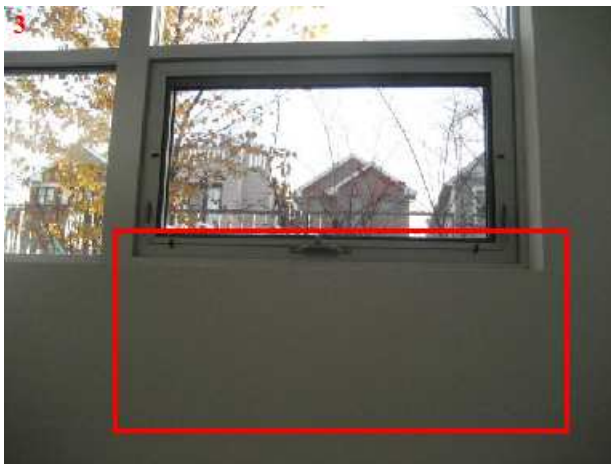
- The SE corner of the basement is visible water damaged. The drywall is wet starting at the base of the windows and then down to the foundation. The wall studs and insulation are visibly wet in the water meter access panel. There are also drip marks on the metal window frame above the wet drywall. We cannot determine if the water is coming from the somewhere above the base of the window or from the base of the window. Further evaluation is needed. Photos 1-2

The perimeter walls were spot checked with a moisture meter in the basement. Four areas were found with high moisture concentrations. We recommend that all drywall and insulation be removed in these areas and replaced once the source of the moisture is located. All electrical outlets/facilities in these areas should also be checked for corrosion/moisture damage.

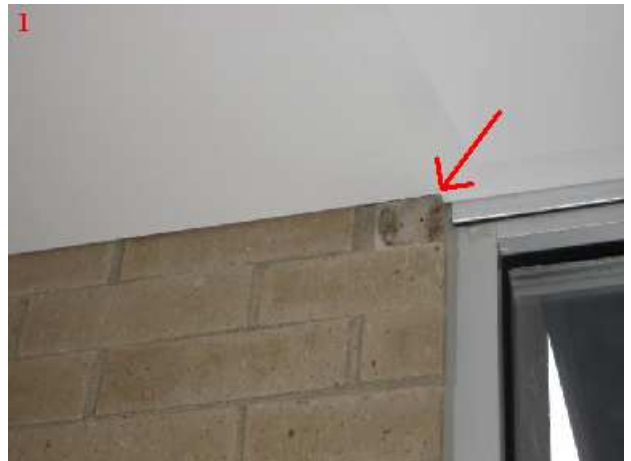
Replace the missing brick in the top right corner of the bedroom fireplace.

Fill the hole in the mortar to the left of the firebox.

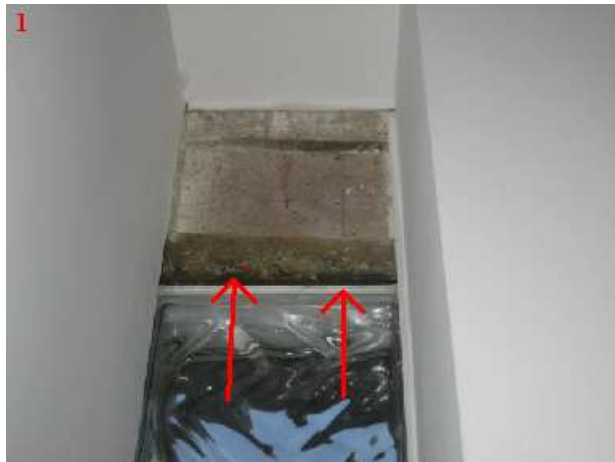
Please touch up and repair all drywall and trim as necessary.  
Professionally clean home.  
Finish masonry at the top of the glass block wall on the 2nd floor.  
See photo
