Inspection Report

Punchlist Example Chicago IL

Property Inspected
Punchlist Example
Chicago IL

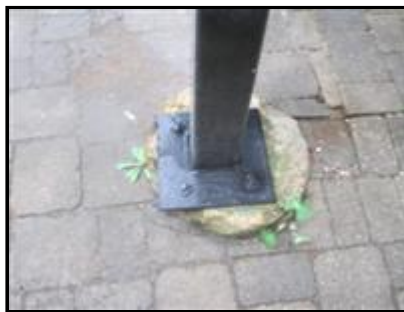
E. Picture 1

(1) The deck columns are not properly seated on the footings. Consult with a qualified decking contractor to determine the best way to support these columns. There are 2 columns that are overhanging the footings. Photo shows west column.

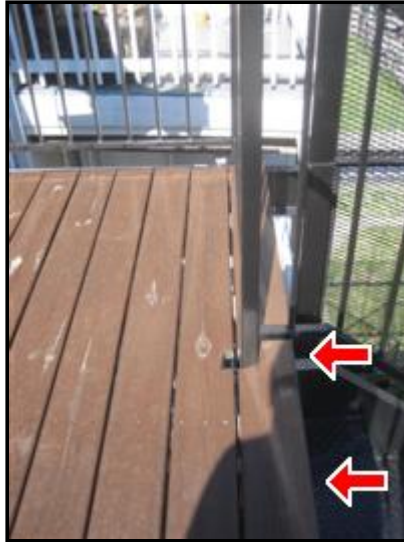
E. Picture 2

(2) Secure all loose/lifting deck boards on the back deck system. Numerous boards are lifting which creates a tripping hazard.

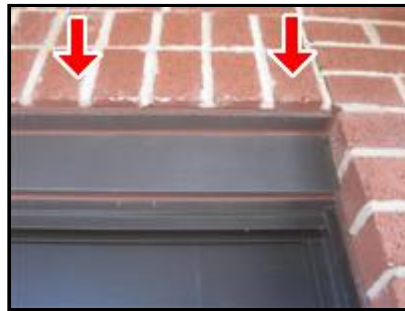
B. Picture 1

Some of the lintels that were painted are now rusting and should be scraped and repainted. Top back deck door.

🏠 (3) Caulking has been added between the door and window lintels and the masonry above the lintels (several back and front deck doors). There should be an open gap between the lintels and the masonry because water needs to drain out of the walls above the lintels. Adding caulk in the gap can trap water in the walls and cause interior leaking. We highly recommend removing all caulking between lintels and masonry.

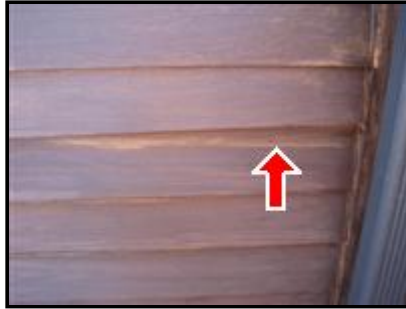
🏠 The siding on the upper front and back deck walls is not well installed or well stained. Some pieces are loose and/or falling. Consult with a qualified siding contractor to secure all loose siding. Add a new coat of paint/stain.

C. Picture 1 Loose siding piece - top level near west side

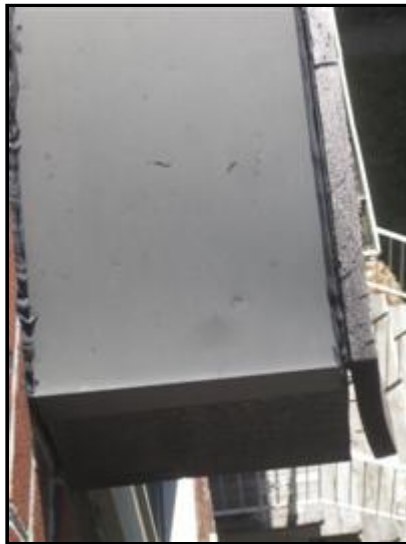
E. Picture 1

The wood trim above the top floor front windows is falling off. Replace this trim.

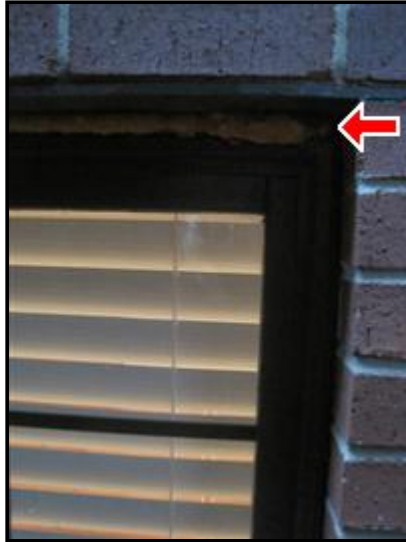
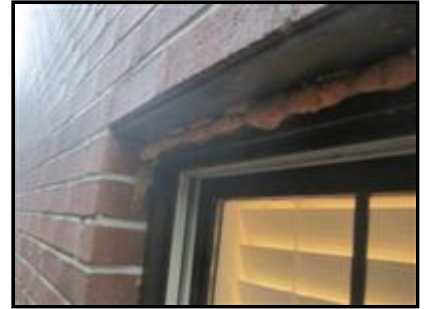
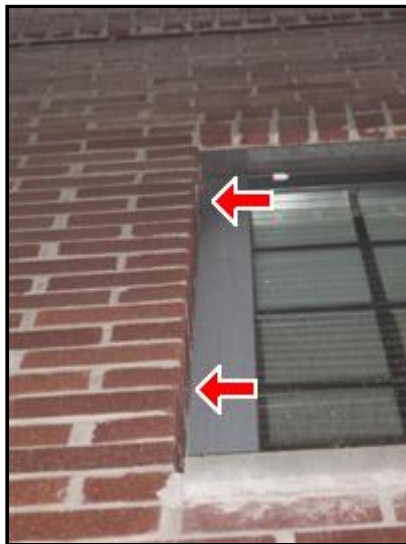
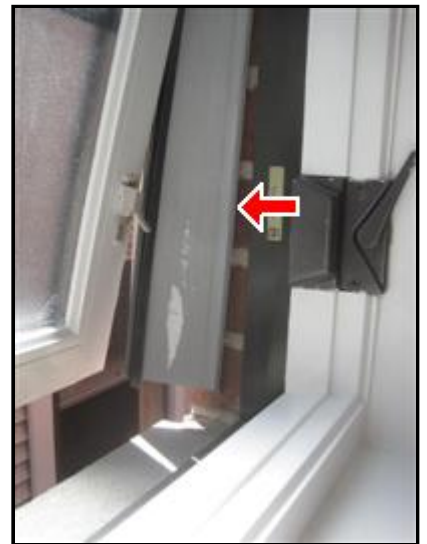
The trim around many of the window frames is not complete and insulation is visible. Other windows appear to have trim installed but there are large gaps and the trim is loose and/or falling. Consult with a qualified window contractor to repair the improperly installed trim and to finish the missing trim.

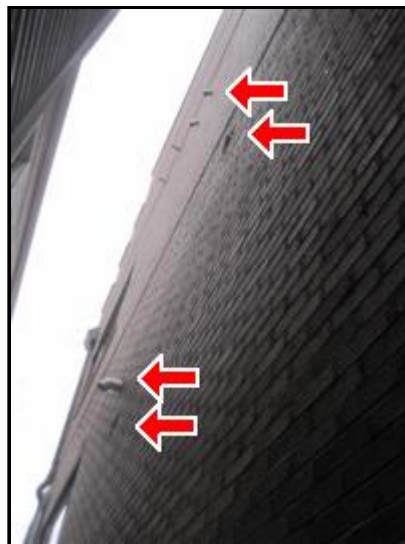
O. Picture 1

There are numerous incomplete vents on the east and west walls. Install all vent covers, elbows and screens. Then caulk all openings so the walls are water and critter proof.

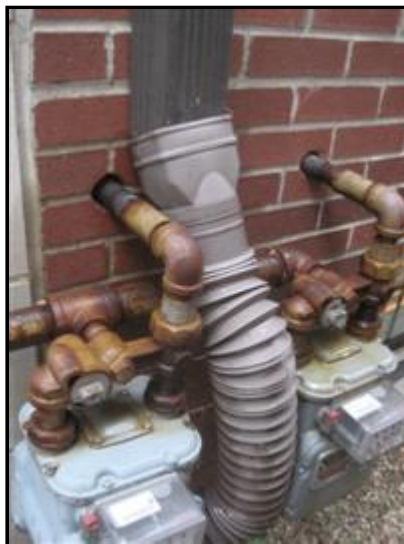
D. Picture 1

All plastic sections of the downspouts should be replaced with aluminum piping. Consult with a qualified contractor.

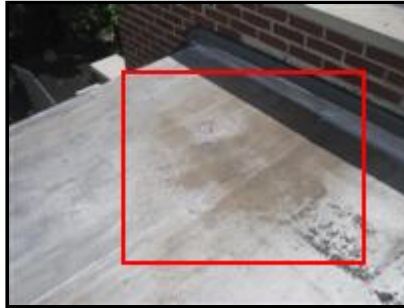
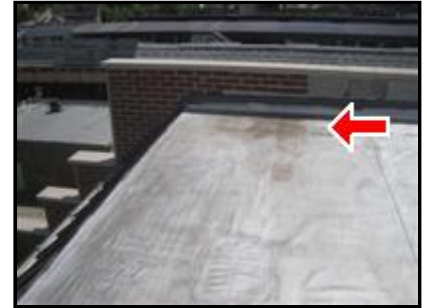
(1) Some minor ponding was noted on the roof in the NE corner - see photo. Re-pitch this area as necessary so water drains into the gutters.

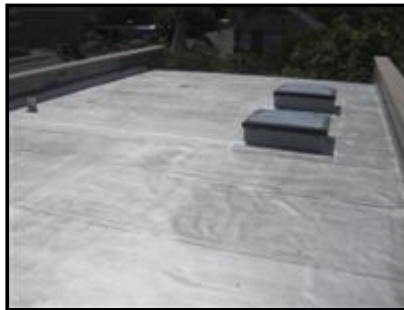
(2) The average life expectancy of a modified bitumen flat roof is about 18 to 20 years.

E. Picture 3 General view of roof

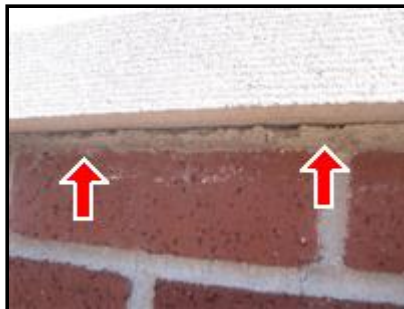
L. Picture 1

(1) There are no visible flashings under the limestone parapet wall caps throughout the home (front deck walls, back deck walls and upper parapets). Without flashings water will leak into the caps and then into the walls. Sometimes flashings are present but not visible. Please have a qualified roofer or mason check for flashings. If they are missing they need to be added.

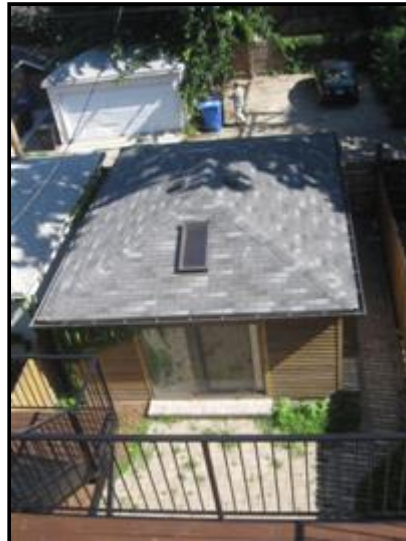
B. Picture 1

(1) Re-stain or paint the garage siding as necessary so the wood does not deteriorate.

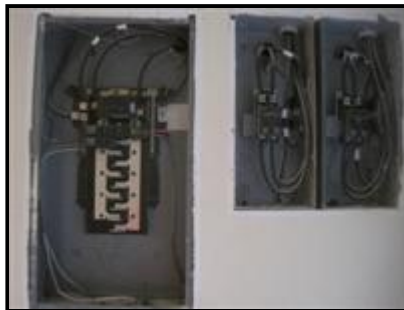
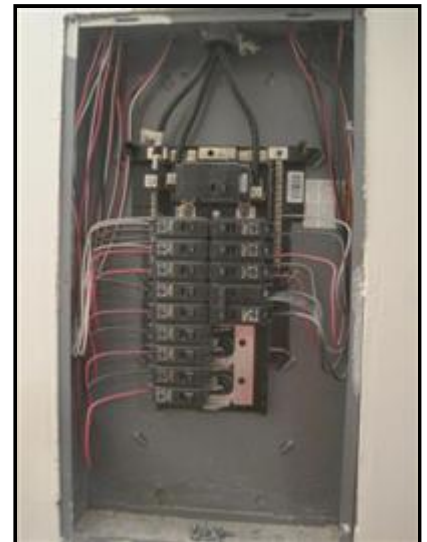
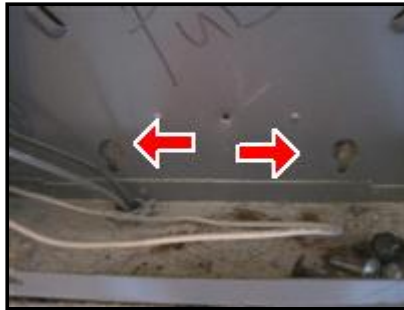
C. Picture 1 Public panel on left, 2 shut-off panels on right

C. Picture 2 Garden unit panel

(2) Four of the electrical panels have been mounted in direct contact with the foundation - the 2 main shut off panels, the public

panel and the garden unit panel (all located in the back basement hallway). Chicago does not allow this because moisture from the foundation can seep into the panel and cause corrosion. Panels should typically be mounted with an air gap between the panel and the foundation or a piece of plywood. Consult with a qualified electrician to remount these panels as required.

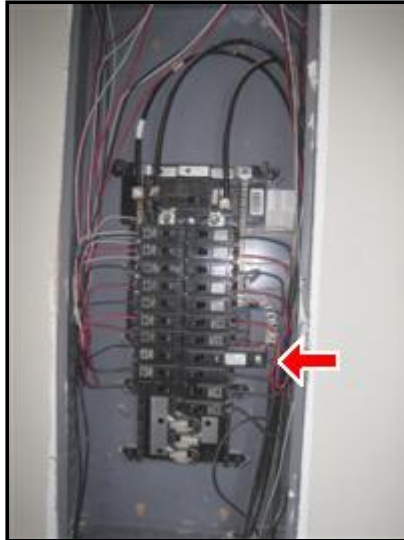
H. Picture 1

AFCI breakers are required on all bedroom circuits. There is only one AFCI breaker in the main panel. Consult with a qualified electrician to add AFCI breakers on all bedroom circuits, including the garden unit.

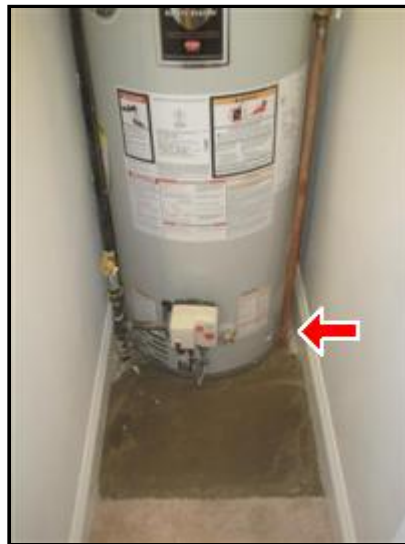
P. Picture 1

The temperature pressure relief valve on the garden unit water heater leaks when the water heater is running. This could be because of a faulty TPR valve or because there is too much pressure building up in the tank. Further evaluation and repair is needed. Once the water heater is repaired replaced damaged flooring, baseboards and drywall.

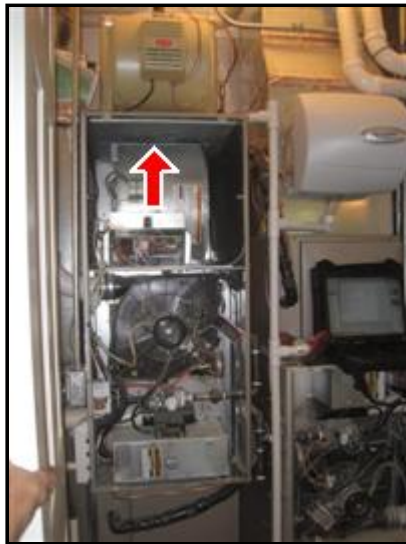
- The water line is not hooked up for the garden unit humidifier. Install water heater.
- The left humidifier is leaking heavily into the blower motor cabinet. We cannot see the underside of the humidifier to determine what is wrong. Consult with a qualified HVAC contractor to repair this humidifier and clean up the interior of the furnace.

J. Picture 1 Arrow shows area where water came from

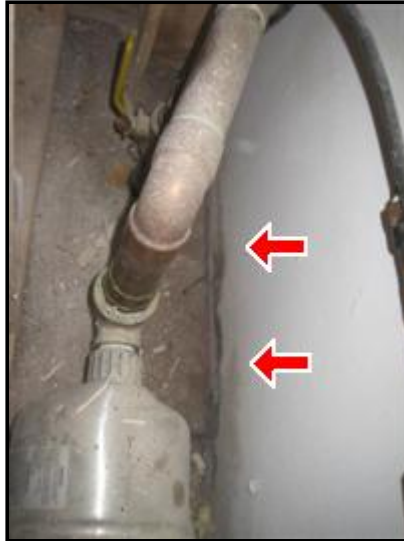
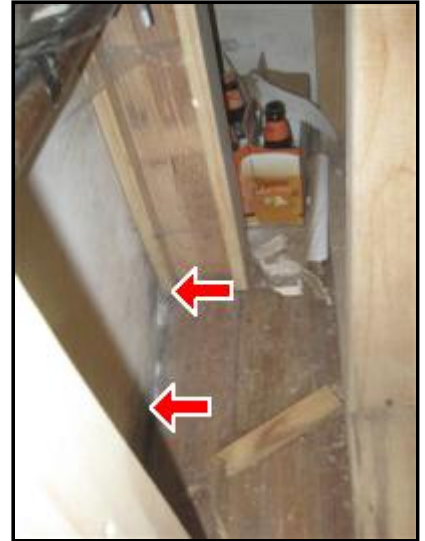
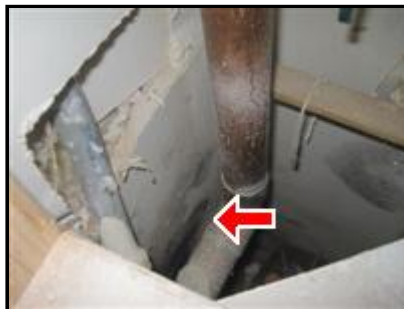
A mold-like substance was visible on the walls around the water meter (see photos) and a mold-like odor was present in the access panel for the whirlpool along the east foundation. Additionally, as noted below all of the drywall around the perimeter of the home below the foundation line was wet when tested with a moisture meter at the inspection. Mold can only be present when there is water and a

food source for the mold. See the Moisture Section of this report for more information regarding the moisture. Given that some mold-like substance is visible we highly recommend either further mold testing to determine the extent of additional mold behind the walls or removal of the drywall/baseboards around the perimeter of the garden unit. Electrical facilities, wall studs, sills and insulation should also be checked for water damage and replaced once the seepage is stopped.

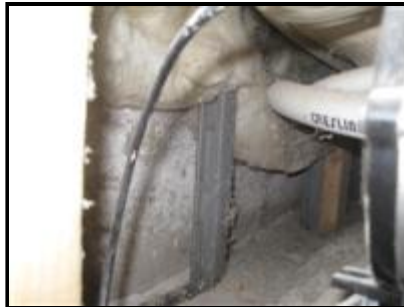
C. Picture 1

Efflorescence is present on the foundation wall in the access panel. This indicates seepage and is likely why all of the walls tested as being wet during the inspection.

It is very common for there to be evidence of seepage in old foundation walls. Seepage generally occurs because of poor exterior grading and foundation deterioration. The presence of efflorescence on the walls (white mineral deposits) is an indication of ongoing seepage. We do not recommend finishing basement walls where seepage is occurring because the moisture can cause mold growth on wall board. Consult with a qualified basement water proofing contractor to determine the best ways to stop seepage for this property.

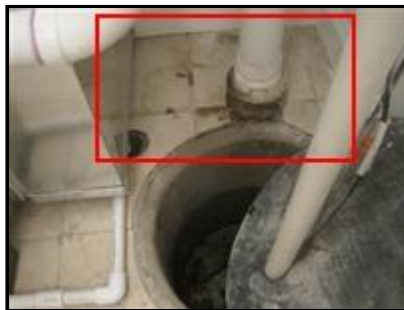
G. Picture 1

There is water damage on the tile around the sump pump and evidence of a mop being used. When/why did this pit back up?

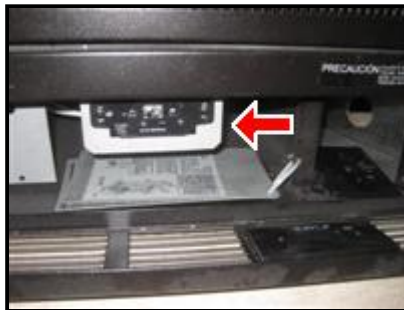
A. Picture 1

- (1) Please complete the following on the living room fireplace:
 - install a gas shut-off outside the firebox
 - install the face plate in the lower control panel - see photo

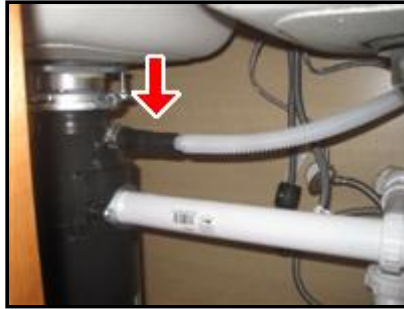
M. Picture 1

(1) The dishwasher drains is running into the disposal. This type of connection is not recommended because it creates a cross-connect between the two appliances. If the disposal is clogged and the dishwasher is running, it is possible to pull bacteria out of the disposal and into the dishwasher. Consult with a qualified plumber to connect the dishwasher drain properly (outside of the disposal). Garden unit.

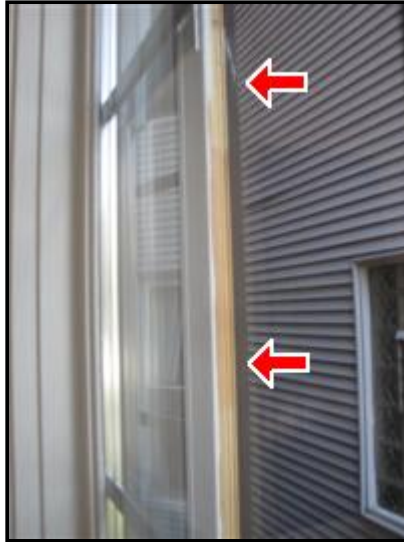
G. Picture 1

(2) Some parts of the wood window frames are not fully painted. The wood needs to be painted so it will not absorb water. Finish painting all operable windows.

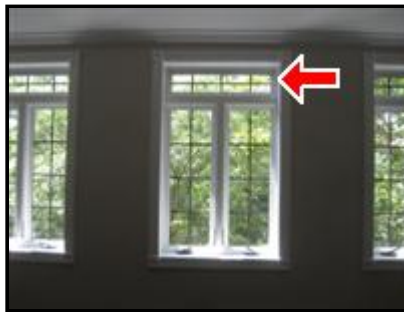
G. Picture 2

(3) The fixed pane window in the center of the front 2nd floor bedroom is cracked. Replace.

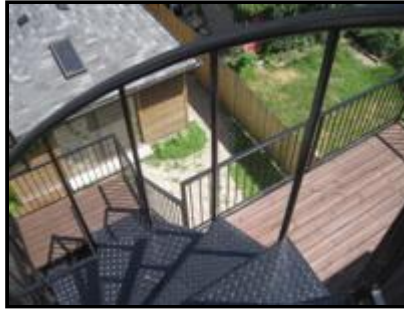
D. Picture 1

The spiral stair railings have gaps wider than 4 inches. This is considered a safety concern because children and small animals may slide through the railings. Consult with a qualified contractor to install railing spindles so that gaps are no more than 4 inches wide.
