Inspection Report

Split-block Example Chicago IL

All About Homes, LLC

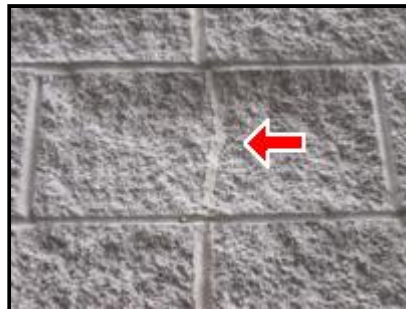
B. Picture 1

- Caulking has been used to repair cracks in blocks throughout the building (see photo). The use of caulk to repair cracking in block buildings is against the block manufacturer's recommendations and against the standards set by the National Masonry Institute. The use of caulking can trap water inside the block. We recommend that all caulking that has been used on this building be removed and that all cracks be properly tuck pointed (old mortar should be ground out and new mortar should be installed). Consult with a qualified mason to further evaluate this situation.

- Efflorescence and rust was visible on the concrete blocks throughout the east wall. Efflorescence is a mineral deposit left over after masonry products and water mix. Efflorescence on concrete blocks is generally a sign that water is getting into the block. If the blocks are properly sealed and the building is properly constructed, then only minimal amounts of water (ideally, no water) should enter the blocks and efflorescence should not be present. We cannot determine if the rust and efflorescence are present because of problems with the decking or because the masonry is taking on too much water.

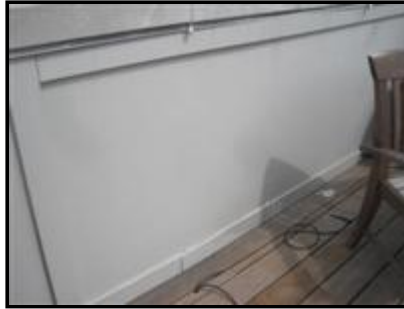
H. Picture 1

The inside of the parapet walls around the roof deck have been covered with a fiber board. It is important that the interior side of the block parapet walls be properly sealed. Because of the siding we cannot determine if the block is sealed.

Many of the caulk joints in this siding have failed and need to be re-caulked. If leaking is noted below the roof deck, expect to remove all siding so the block can be inspected.

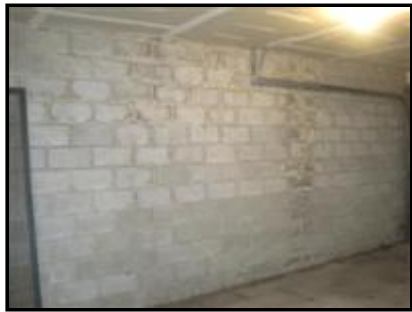
C. Picture 1

The interior concrete block wall in the garage has been leaking. See photo. There are water stains throughout the north wall. Has the garage been maintained/sealed in the same way as the main building? If so, this could be a sign that water has been getting into the concrete block walls. If this occurs behind drywall then mold-growth can become an issue. See notes in Exterior Section regarding concrete block.

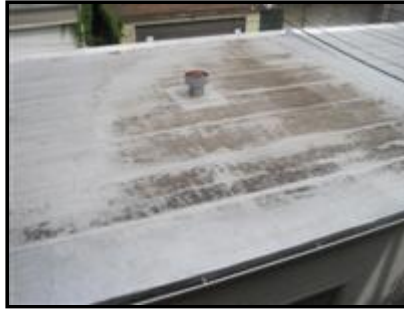
D. Picture 1

Recommend adding a new silver coating on the garage roof. This will reduce cracking.

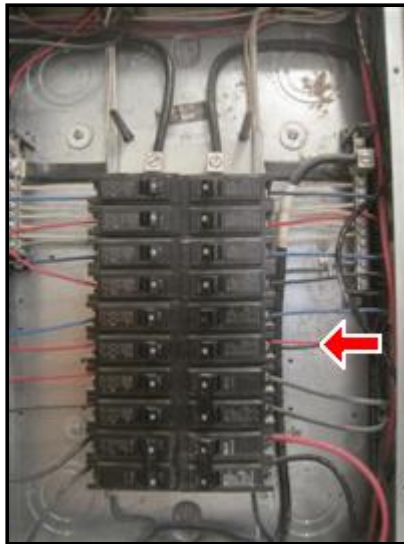
K. Picture 1

Double tapping: One double tap
 Double-tapping was noted in the electrical panel. One double-tapped breakers was present. Double-tapping means that two circuits are running into one breaker. This is a safety concern because the circuits can overheat and because wires in the panel can become loose. Consult with a qualified electrician to determine the best way to remove all double-taps.

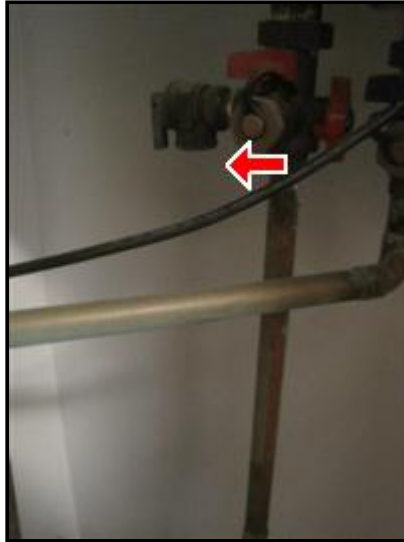
N. Picture 1

The temperature pressure relief valve should have a pipe extension that runs from the valve to within 6 inches of the floor. The extension is missing on this water heater. Consult with a qualified plumber to install the proper extension.

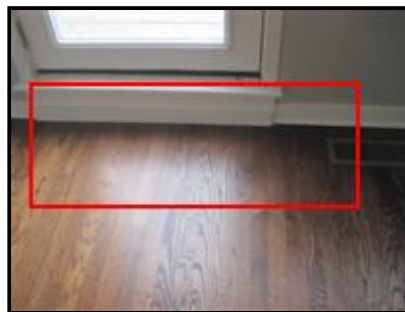
B. Picture 1

🏠 (2) It appears that the master bedroom roof deck door has been leaking. The floor in front of the door is water damaged. Moisture levels were elevated on this floor at the time of the inspection (tested with a moisture meter). Consult with a qualified general contractor or door contractor to repair this door so it does not leak. This leaking may be the cause of the water damage noted on the 1st floor bedroom ceiling. Once the leaking is stopped then replace/refinish the damaged floor boards.

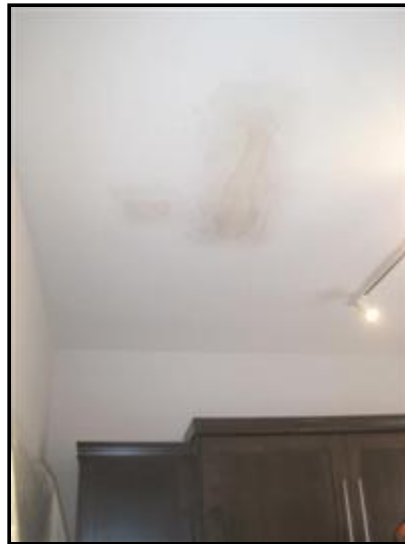
🏠 There is a large water spot on the ceiling of the 1st floor bedroom. Parts of this area were wet at the time of the inspection (tested with a moisture meter). This area is under the east master bedroom wall so there are a number of problems that could cause this leaking. Area to check include the connection between the roof (under the deck) and the east wall, the door flashings, the siding and the window flashings. It appears that caulking has recently been added on the siding but this does not appear to have stopped the problem. Additionally, caulking is not a long-term fix for this type of problem because it will fail over time. Consult with a qualified general contractor, roofer and/

or door installer to find the water source and make all necessary repairs.

C. Picture 1 Wet area on bedroom ceiling

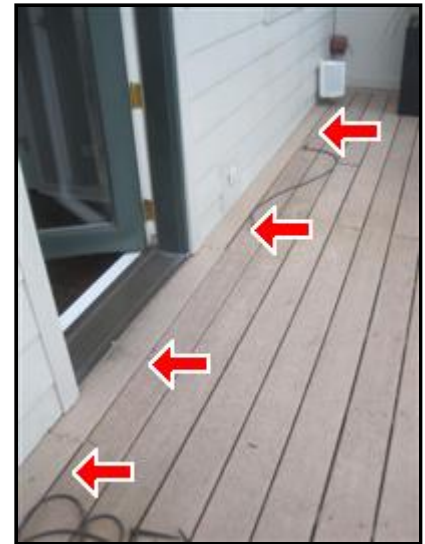
C. Picture 2 Roof connection to wall covered by decking

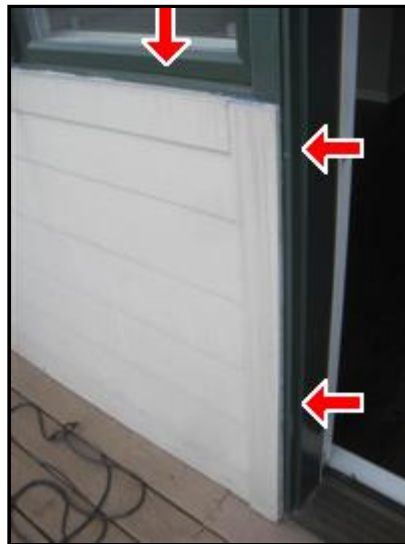
C. Picture 3 Recently caulked siding near door

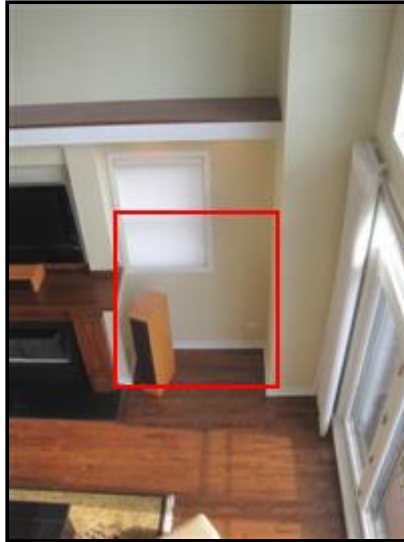
D. Picture 1

- Wall on either side of the fireplace. Some cracking was noted so the walls were tested with a moisture meter and they were wet on both sides. Additionally some staining is noted near the base of the wall on the west side of the fireplace. Photo 1

- consult with qualified masons, architects and general contractors to determine why the water is getting into the walls
- make all necessary repairs to the masonry to stop the leaking
- remove all drywall and insulation on the impacted walls to determine the extent of the interior damage. Check for mold growth.
- check all electrical and low voltage facilities on the impacted walls for corrosion
- check the floor joists for water damage along the perimeter walls. If the joists have gotten wet then a structural engineer is needed for further evaluation
- remove and replace all impacted materials
- if mold is found in the walls then all proper remediation steps should be followed with a licensed mold remediation contractor

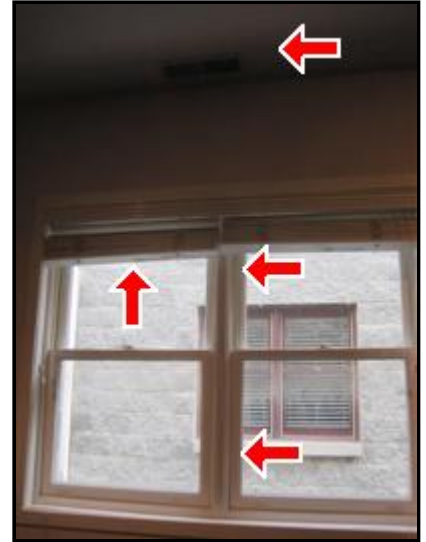
D. Picture 2

- Water stains are noted around the HVAC duct above the window in the 1st floor guest bedroom. Stains are also noted in the center of the window frame below the HVAC duct and on the base of the window blinds. Photo 2

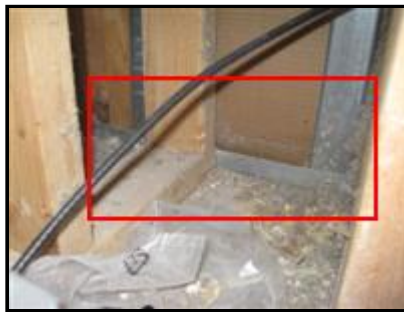
D. Picture 3

- Some buckling of the drywall/paint was noted under the master bedroom window. This could be from water damage or from poor drywall installation.
- Water marks were noted on the east wall that is visible through the whirlpool motor access panel. This may also be indicative of water entering through the block on the east wall. Photo 3

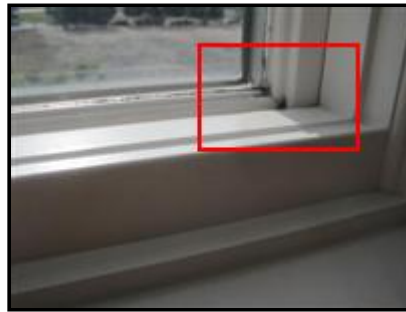
G. Picture 1

(2) There is evidence of damage to the window frames for condensation. There is a small amount of a mold-like substance on the north living room window on the west wall. Photo 1. There are also drip marks on the tops of many of the window sashes. These types of drip marks are often from condensation. Condensation can occur because of over humidification or because of high humidity levels in the walls due to the concrete block. It can also occur because blinds are left closed on cold days. We cannot determine the cause of the condensation damage in this unit.
