## Inspection Report

### 2-flat Example Chicago IL

2-flat Example

Chicago IL

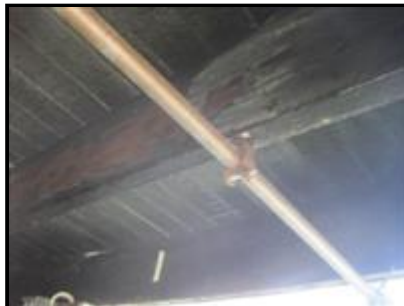
(2) Several joists on the exposed underside of the enclosed back porch are fire-damaged. When did a fire occur? These boards should be reinforced with sister boards. Consult with a qualified contractor.

C. Picture 1 Fire damaged joists in NE corner

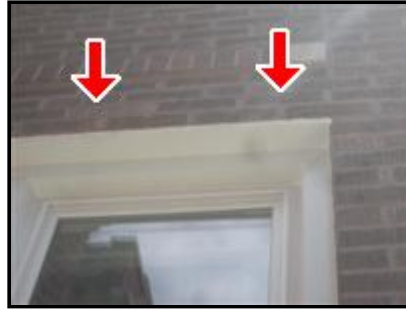
C. Picture 1

walls. The area above windows and doors is a natural drainage point for a masonry wall. Therefore it is important that water inside the walls be able to escape above the doors and windows. When the steel lintels are wrapped with aluminum and then caulked, as they have been on this home, water can become trapped on the lintels which leads to premature failure of the lintels. We recommend that all caulking be removed so that the lintels can "breathe". Consult with a qualified mason to make all repairs.

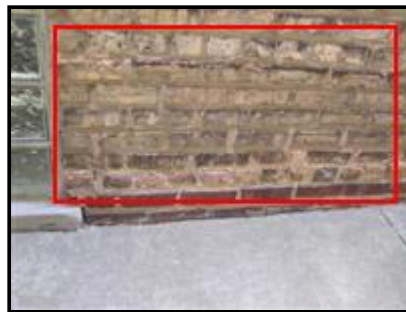
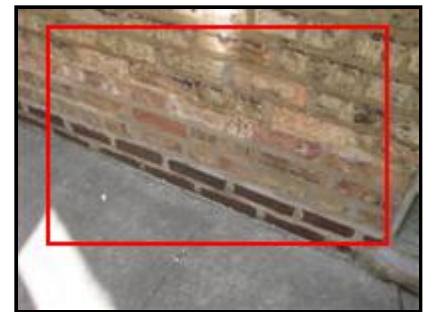
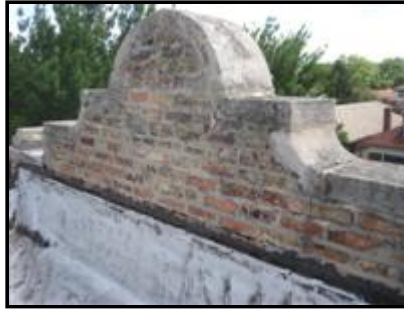
📌 (2) Some areas on the brick walls need to be tuck pointed. Tuck pointing is recommended when any of the following conditions exist: 1) there is at least 1/4 inch mortar loss between bricks, 2) cracks are large enough to slide a business card through, and/or 3) the bricks are in any way deteriorated or damaged. Old mortar should be ground out prior to installing new mortar. If new mortar is installed without first grinding out the old mortar, the new mortar will not adhere properly. Be sure to obtain multiple estimates for work and hire only reputable and experienced masons.

The areas in need of tuck pointing the most include the base of the west wall (see photos 1/2) and the interior of the front parapet (photo 3).

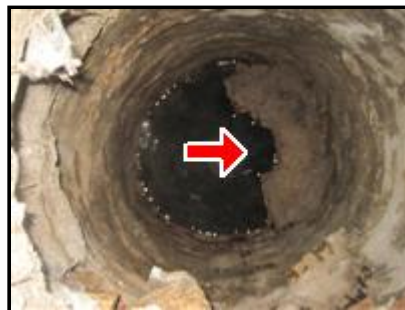
L. Picture 1

(3) The drain line in the catch basin no longer has a trap. This will allow debris in the basin to run through the drain line. We recommend adding a trap on this drain line. Consult with a qualified plumber to install a trap.

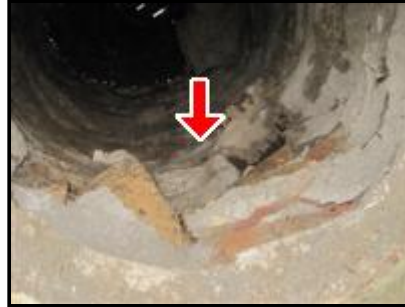
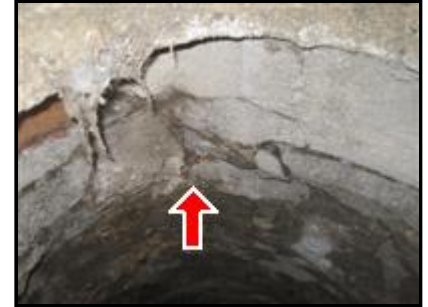
(4) The brick walls of the catch basin need to be repaired so that loose pieces of masonry do not fall into the basin and become lodged in the drain line. Consult with a qualified mason to make all necessary repairs.

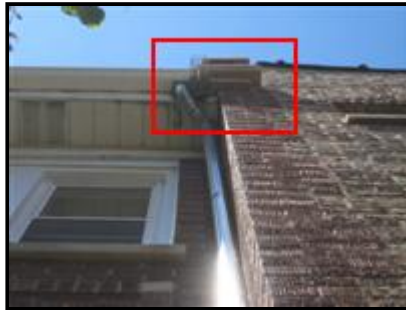
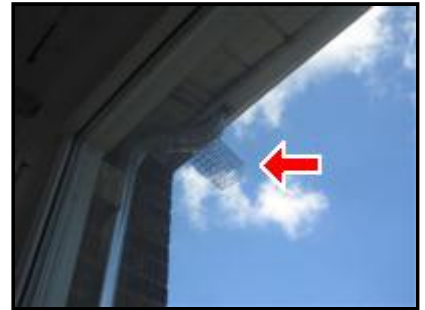
🏠 (1) There is unusual wire mesh in the gutter area on the east side of the home where the pitched section of roof meets the brick wall. It appears that this may have been added to keep critters out of the soffits. Please provide an explanation for the presence of this wiring. If this is present to keep critters out of the soffits then we recommend removing this mesh and working with a gutter contractor to repair the damaged soffit wrapping and fill all holes as necessary.

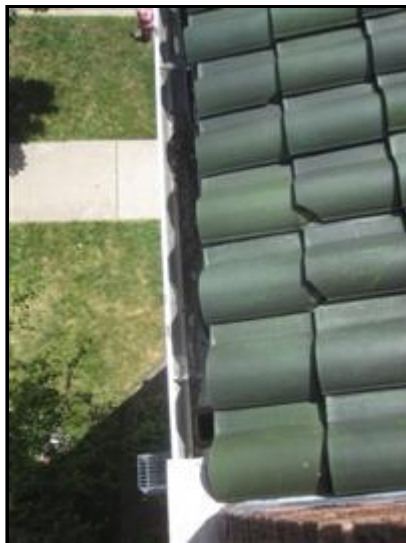
C. Picture 3

(2) We recommend removing the screens from the gutters around the tile roof. These have collapsed and are not trapping debris inside the gutters.

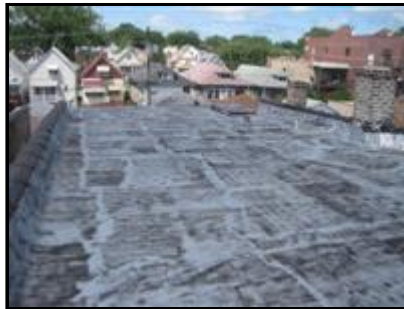
E. Picture 1

(1) The silver coating on the roof is worn. The silver coating is important because it reduces cracking in the membrane and reflects the sun. Consult with a qualified roofer to apply a new silver coating on this roof.

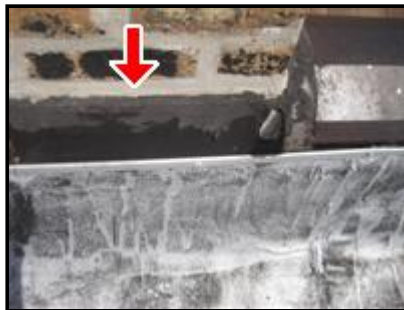
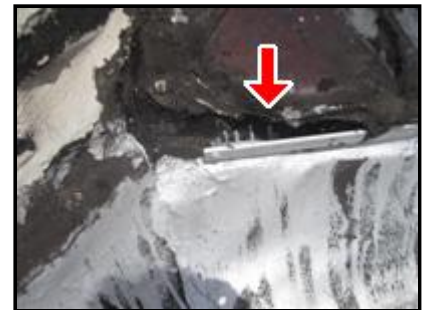
- 🏠 (1) There are 3 basic ways to connect a roof to the parapet walls.
- The preferred method is to roll the membrane over the top of the masonry and then install the wall caps. This keeps water from seeping through the caps and running into the walls. It also prevents the membrane from separating from the wall when it is attached vertically.
  - The next best method is to use metal termination bars to attach the roofing membrane onto the vertical parapet wall. The termination bars need to be properly fastened and caulking.
  - The least desirable way to connect the membrane is to use tar at the top edge of the roofing membrane on the vertical wall surface. As the tar fails/cracks the roofing membrane can pull away from the masonry and this can lead to leaking.

On this roof, termination bars have been used but they are not properly secured to the roofing membrane so they are not preventing the roof from separating from the parapet walls. Either add properly installed termination bars or roll the roofing membrane under the wall caps.

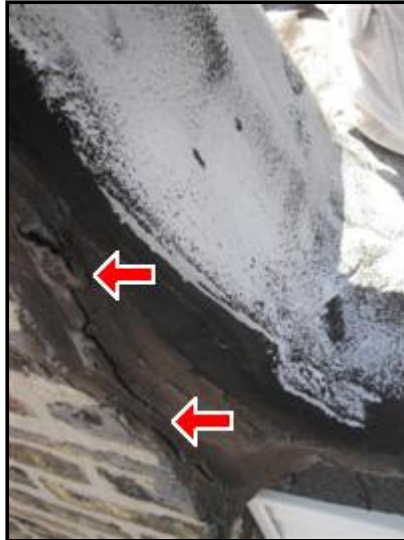
H. Picture 3

- The flashings are cracking around the vents in the roof. Photo 3

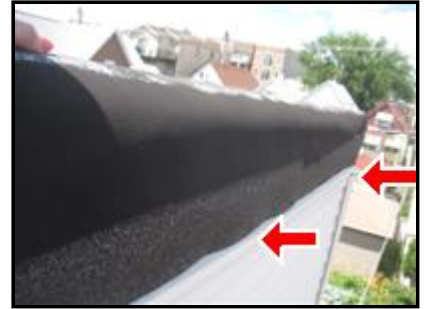
H. Picture 4

- Tar has been used around the chimneys. Tar is not a recommended flashing because it will crack and leaking can occur. Photo 4

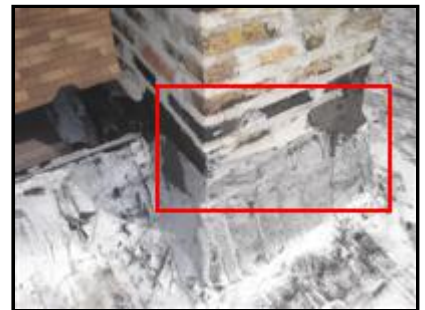
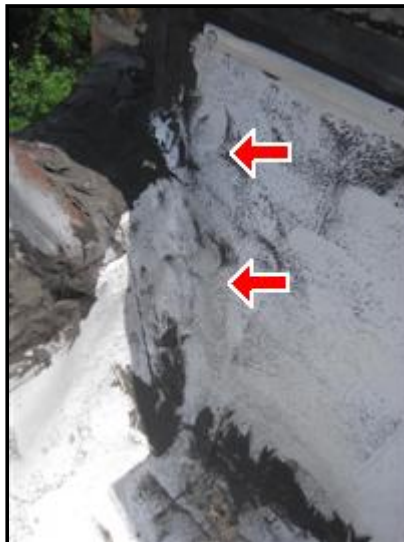
- The tile roof is not well connected the south masonry wall. Tar has been used here and it is cracking. Photos 6/7

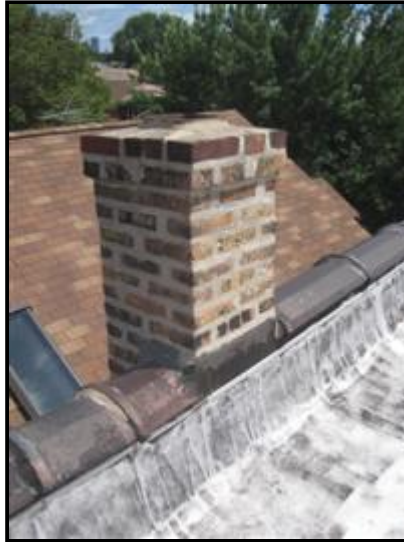
There are 3 chimneys on the east wall of the building. It appears that only the center chimney is in use. Therefore we recommend capping the other two so that critters do not become trapped inside.

A. Picture 1 North chimney - does not appear active

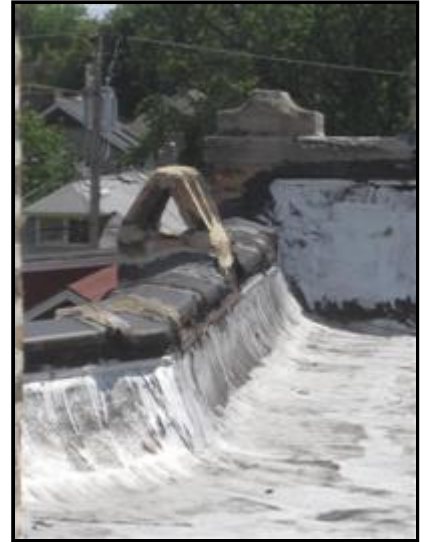
A. Picture 2 South chimney does not appear active

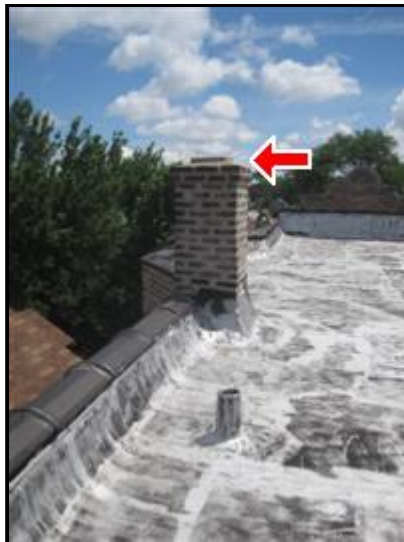
B. Picture 1

This chimney does not have a cap or screen. As a result debris and critters can enter the chimney. Chimney blockages can be very dangerous because flue gases can back up into a home. We highly recommend adding a proper chimney cap for the boiler and water heater chimney. Consult with a qualified chimney sweep.

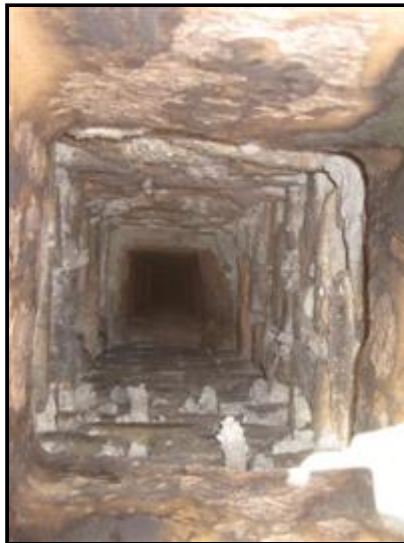
E. Picture 1

The boiler and water heater are relatively new. Newer gas appliances require smaller chimney flues than were originally built in homes of this age. To make old chimney's smaller, metal liners can be added inside old flues. The boiler/water heater chimney is not properly lined. Part of the flue is not lined at all and part has a heavily deteriorated clay liner. If the flue is not sized correctly or if there is deterioration, then the gas appliances may not draft properly and flue gases can end up in the home. Consult with a qualified chimney contractor to install a proper flue liner.

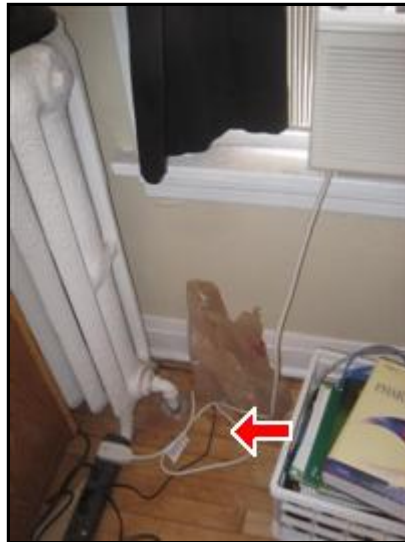
A. Picture 1

(2) All of the top floor units (3) are plugged in with extension cords. The window units need to be plugged directly into wall outlets that are grounded. Consult with an electrician to add the proper outlets within reach of the AC units.

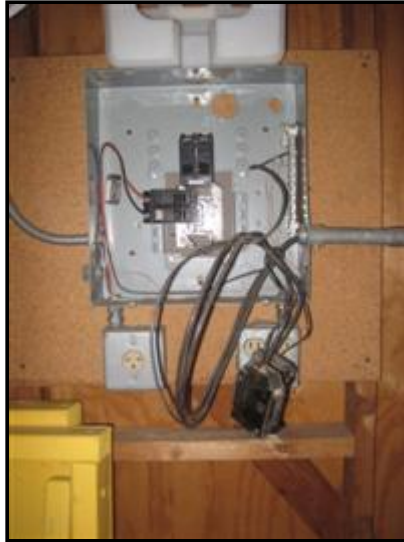
H. Picture 1

There is an electrical panel in the garage that has loose and exposed live wiring. See photo. The wiring that is here is not safe and does not appear necessary. Consult with a qualified electrician to remove this panel and properly wire the garage outlets and lighting. Be sure the outlets are GFI protected.

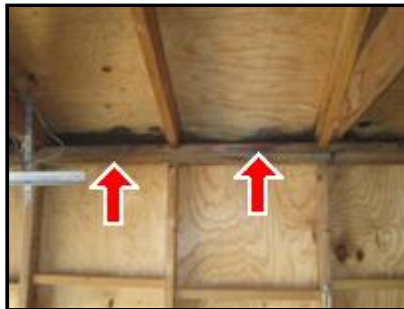
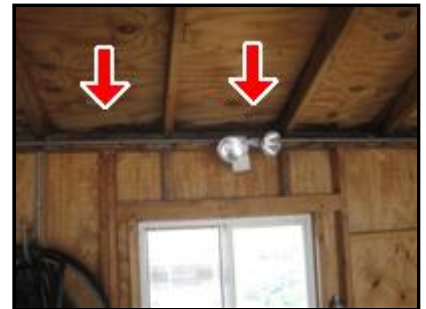
There is water damage and a mold-like substance on the roof decking at the soffits. The soffits, gutters and roof look satisfactory at this time. When did this damage occur? Did this damage occur before the new roof and gutters were installed? Monitor for ongoing leaking and repair as necessary.

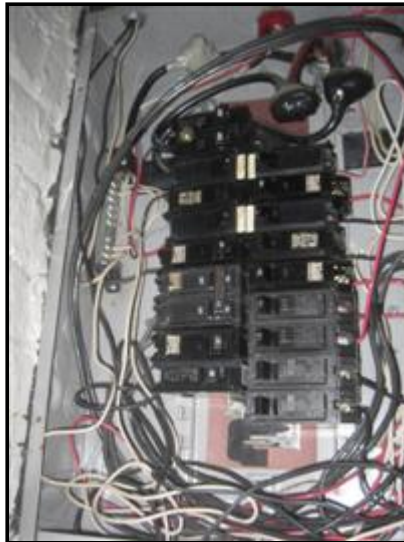
Please label all unlabeled circuits. Photos show panels.

C. Picture 1 Public + unit 1

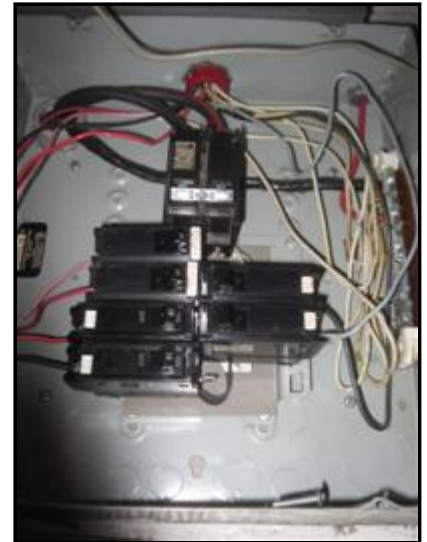
C. Picture 2 Unit 2

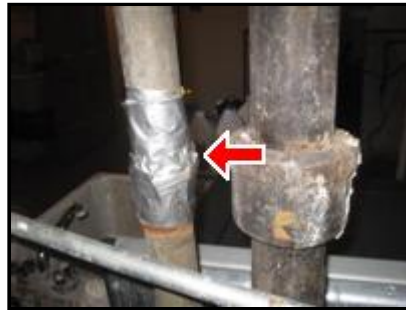
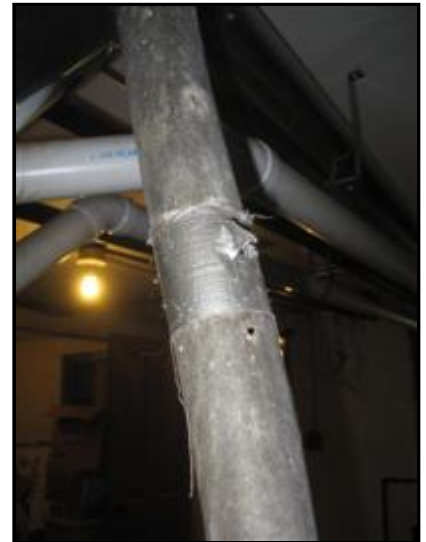
The pipe in the photos is likely the vent for the kitchen drain. It is held together with duct tape and has holes in it. Consult with a qualified plumber to replace this pipe.

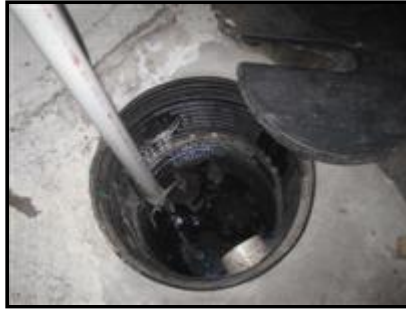
I. Picture 1

There is a pit in the basement with a pump. Why is this pit here? It does not appear that there are any drain tiles around the foundation. Was this installed to manage water if a flood occurs? The water in the pit was very stagnant and had a foul odor. We recommend adding a solid cover over the pit and a vent into the plumbing stack so that all odors are removed from the basement. Consult with a qualified plumber.

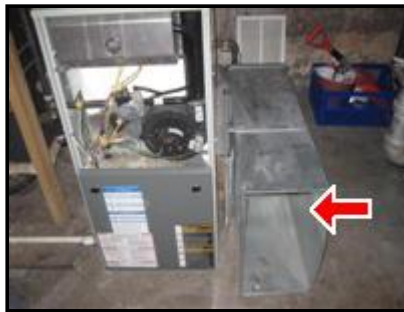
C. Picture 1

The cold air return for the basement furnace is not ducted. Cold air return ducts must be at least 3 feet from the furnace burners so that combustion gases do not get pulled into the main air supply. Recommend extending this duct away from the furnace. Consult with a qualified HVAC contractor.

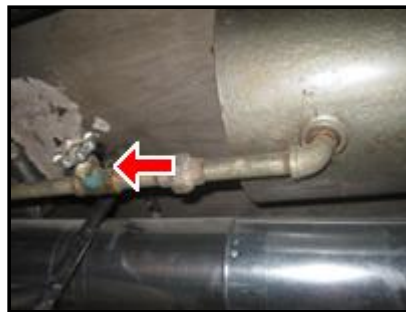
K. Picture 1

The water shut-off valve to the expansion tank is corroded. Consult with a plumber to replace this valve.

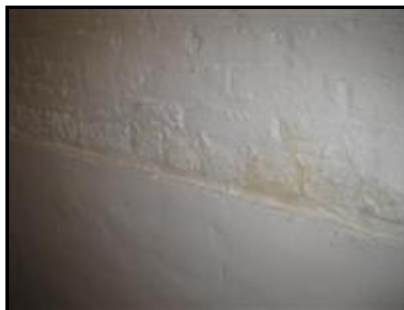
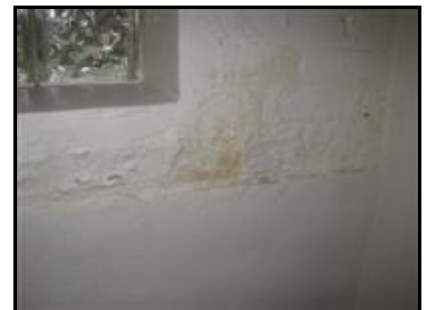
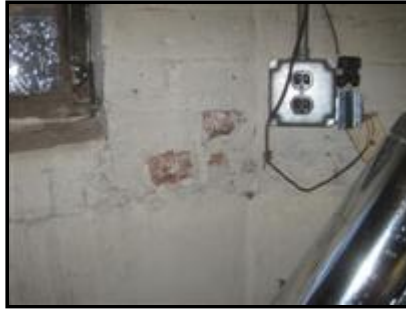
It is very common for there to be evidence of seepage in old foundation walls. Seepage generally occurs because of poor exterior grading and foundation deterioration. The presence of efflorescence on the walls (white mineral deposits) is an indication of ongoing seepage. We do not recommend finishing basement walls where seepage is occurring because the moisture can cause mold growth on wall board. Consult with a qualified basement water proofing contractor to determine the best ways to reduce seepage for this property. Compared with most properties this age, the seepage in this basement is fairly minimal. The seepage is worse on the west wall than the other walls.

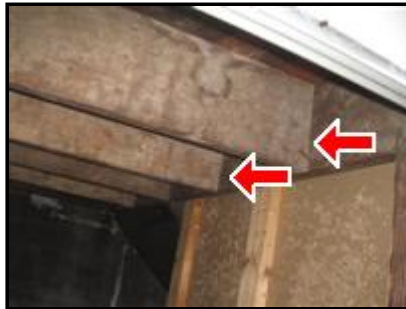
D. Picture 1

Recommend adding joist hangers to support the joists under the front stairs. See photo.

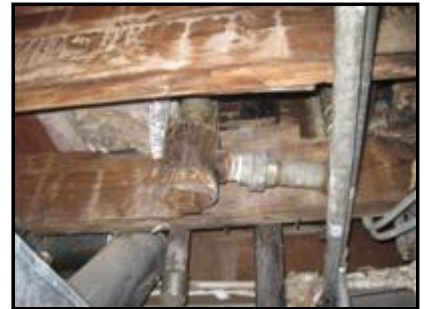
D. Picture 2

Reinforce the damaged and cut joists under the bathroom. See photo 2.

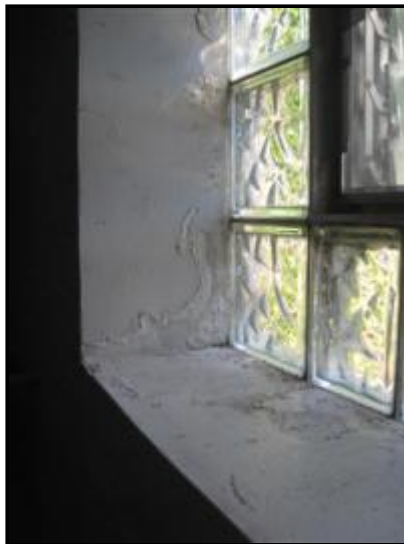
H. Picture 1

(2) There is water damage on the framing of the front basement window. The framing was dry during the inspection. We cannot determine if this is old damage that occurred before the blocks were installed or if this is actively leaking. Given that we have had a lot of recent rain, we expect this is old damage. Monitor for leaking and repair as necessary.

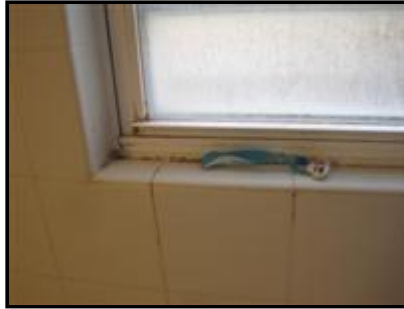
F. Picture 1

The vinyl replacement window in the 2nd floor bath is covered with a mold-like substance. We recommend cleaning with ammonia to try and kill the mold roots. Wait at least 24 hours and then treat with bleach to remove the stains. Be sure to protect this window from exposure to water as much as possible.

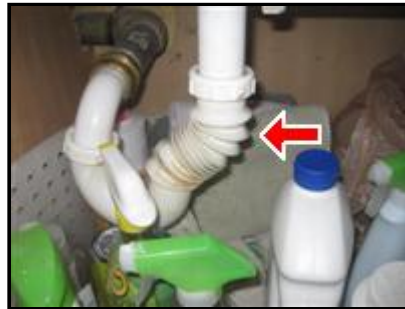
N. Picture 1

The kitchen drain is corrugated PVC. This type of drain piping can lead to slow drainage. We recommend replacing with solid piping.  
1st floor

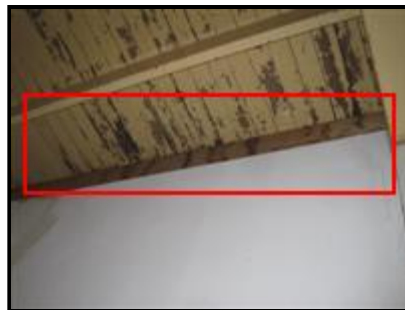
C. Picture 1

(2) It appears that water has been leaking in on the back porch where the gutters connect to the roof. This may be from ice damming in the winter. If ice damming occurs either insulate the attic space and/or add heating coils in the gutters.

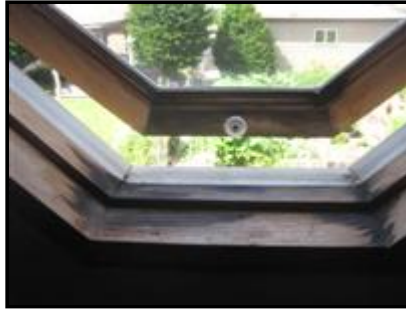
G. Picture 1

(4) The octagonal window on the back porch appears to be leaking. Repair/replace as necessary.
