Inspection, Single Family

Inspected 8/10/07 11:30 AM

Record 20070810a - Inspection, Single Family City Lane, Chicago , IL

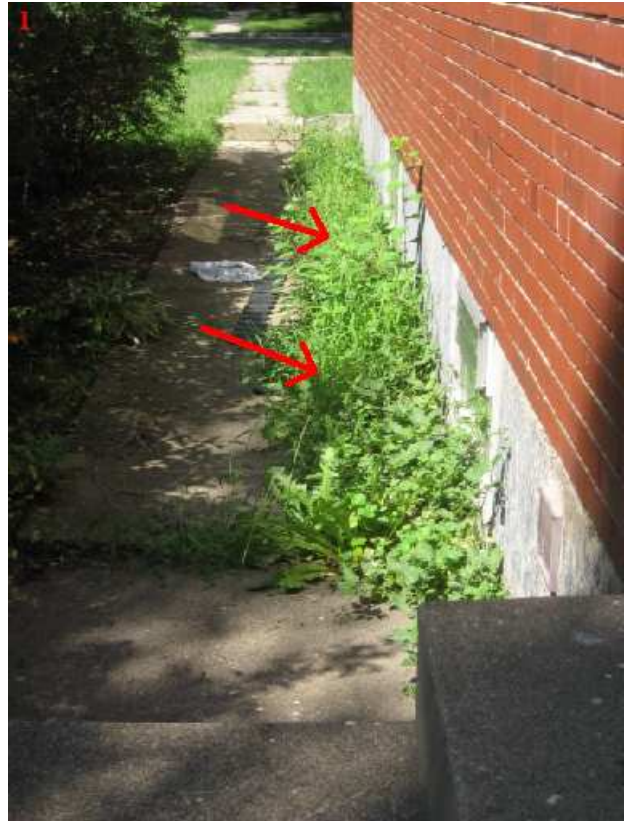
Sat/Minor Repairs Landscaping - South

There is a negative grade on the south side of the home. Consult with a qualified landscaper to re-grade this area so that water does not enter the foundation.

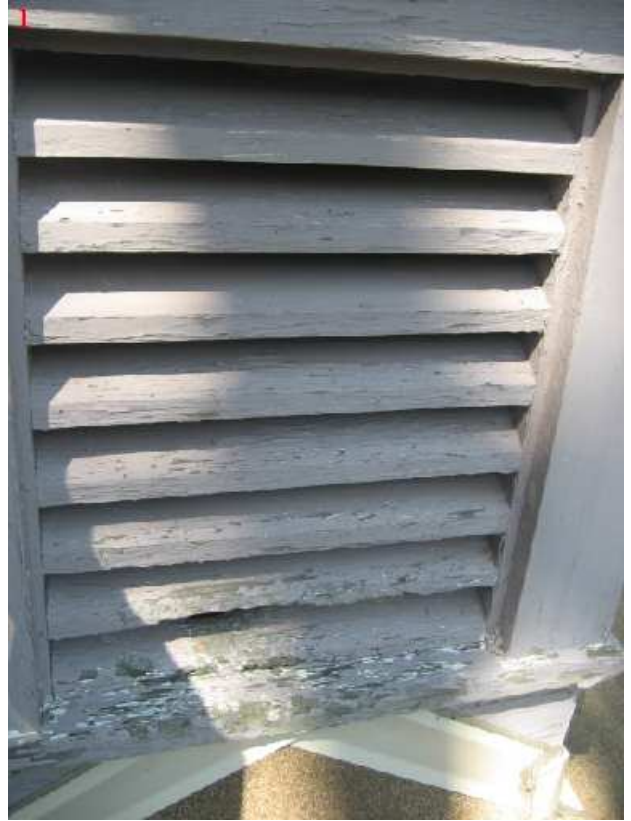
Sat/Minor Repairs **Trim Work - Wood, Loose/cracked paint**

Loose/chipped/cracked paint is noted. Please scrape, sand and repaint to protect the trim material.

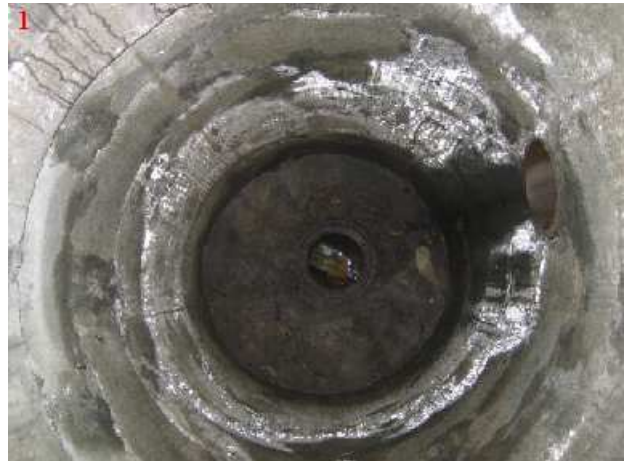
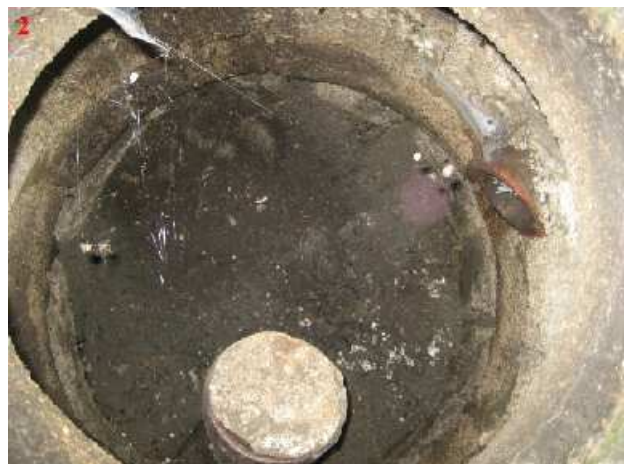
Sat/Minor Repairs Catch Basin - Functional

There are 2 catch basins for this home. The west basin appears active. The south basin does not appear active, but we cannot confirm this. Have the system evaluated by a qualified plumber.

Recommend cleaning catch basin annually. We also recommend having the drain lines scoped by a qualified professional to determine the condition of the drainage system.

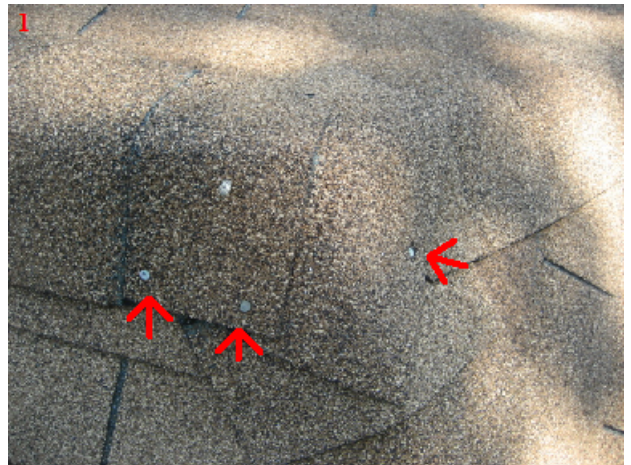
Sat/Minor Repairs Condition - Satisfactory, Seal nail heads

All exposed nail heads should be sealed/caulked on the roof. This will prevent rusting and eventual leaking.

A couple of shingles have broken. Replace these shingles.

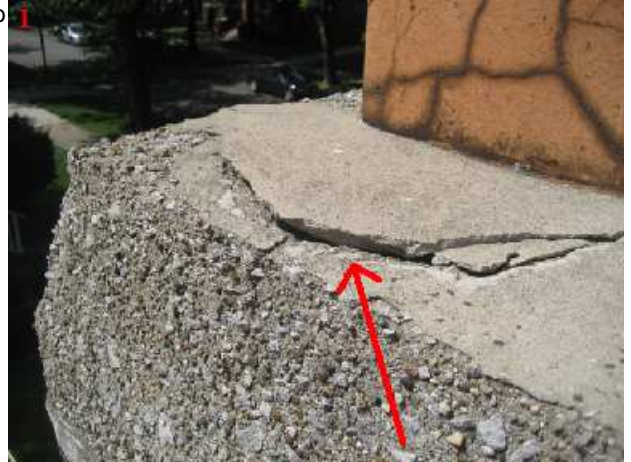
Sat/Minor Repairs CHIMNEY - General Comment

The crown of the west chimney is cracked and should be repaired to keep water from running into the chimney.

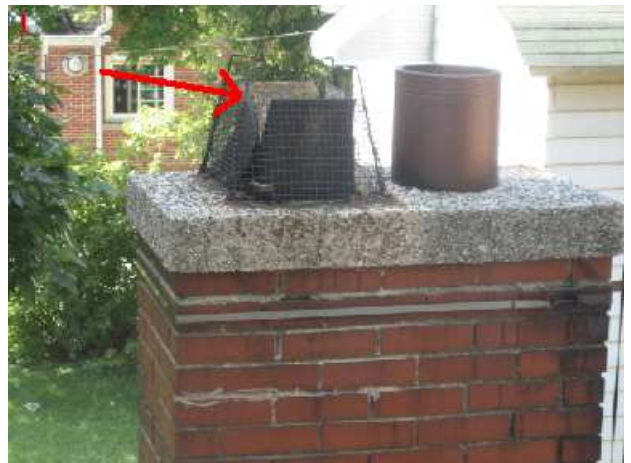
The east flue in the south chimney is damaged at the top of the chimney and the cap is gone. This flue is serving the water heater. Repair the top of the flue and evaluate to determine if the liner is properly sized for the water heater. It is possible that the flue will need to be lined.

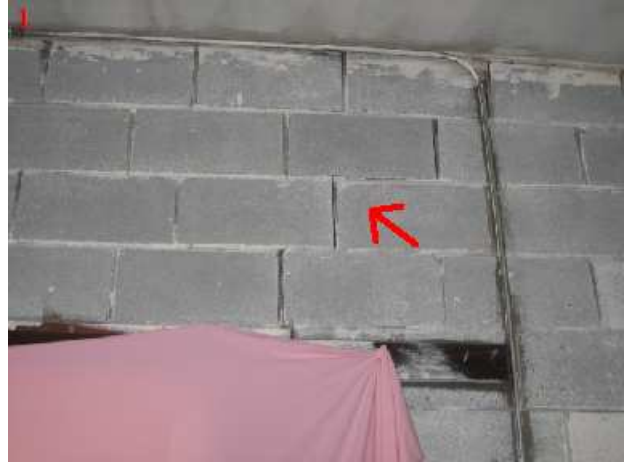
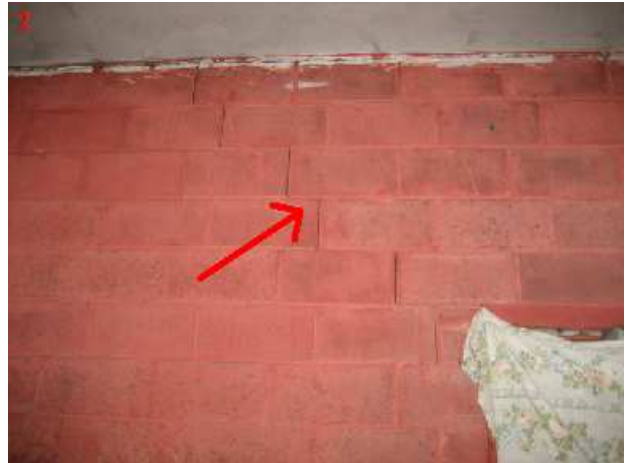
Sat/Minor Repairs Garage Interior Walls - Concrete block

Cracking noted throughout the concrete block. Monitor and consult with a qualified mason to repair as necessary.

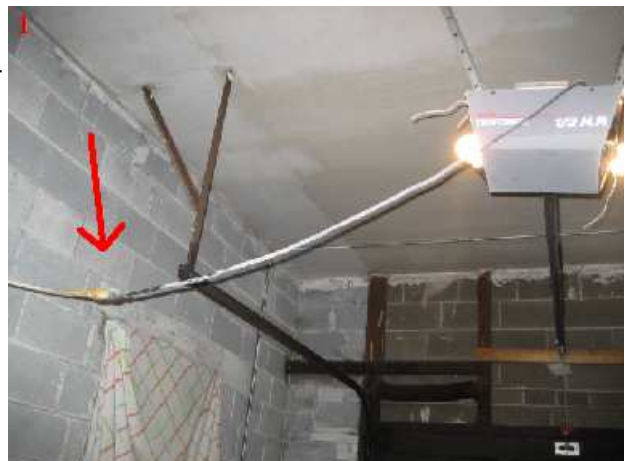
Safety Concern Garage Door Lift Controls - Opener wired with extension cord

Garage door openers should have a dedicated electrical box near the opener. They should not be plugged in with extension cords. Please add a dedicated grounded electrical box for this garage door opener.

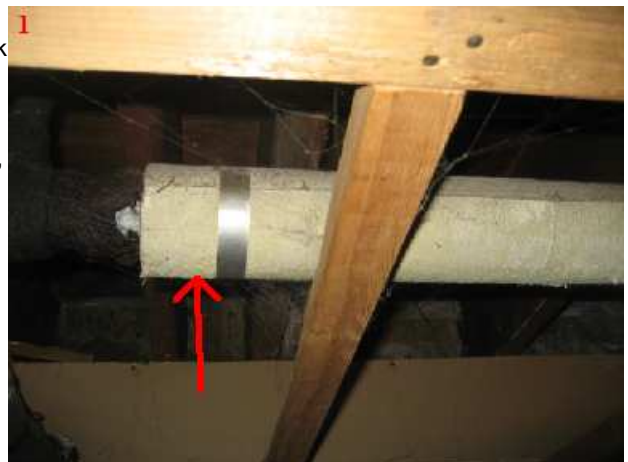
Safety Concern BASEMENT - Presence of asbestos-like materials

There are pipes in the basement with asbestos-like pipe wrapping. This material should be evaluated by a professional licensed to work with these types of materials. Proper control of asbestos requires removal, encapsulation (with a soffit or wall, for example) or a wrap with appropriate marine repair tapes. If asbestos is removed, there are strict protocols requiring containment, continuous air monitoring, and disposal which must be followed.

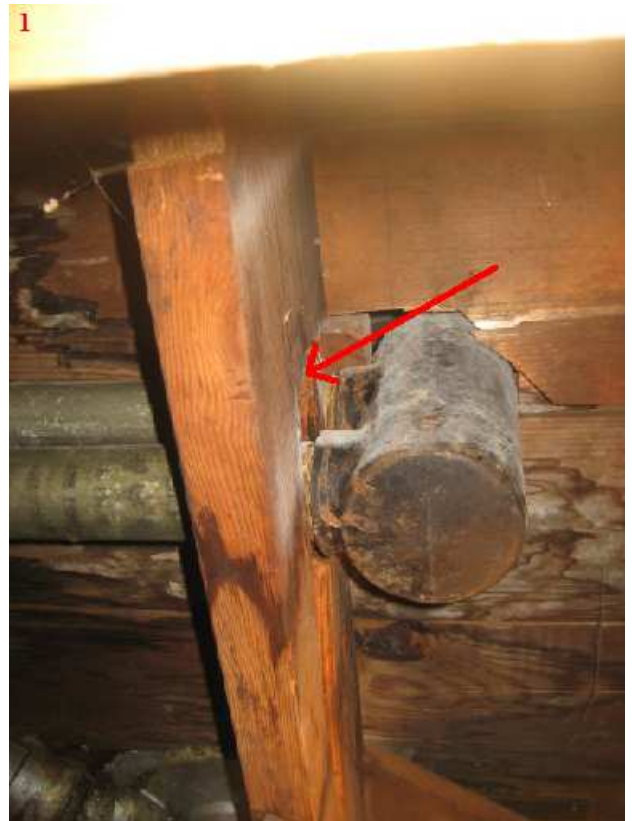
Sat/Minor Repairs Basement Ceiling Joist - 2X10

Other = some joists heavily notched. Reinforce as necessary.
Around bathroom plumbing

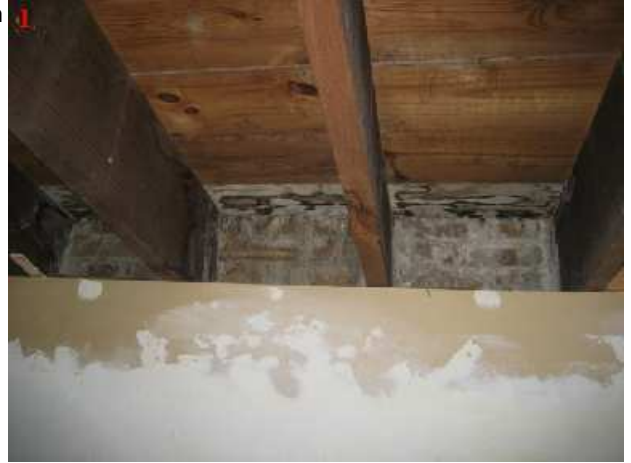
Sat/Minor Repairs Moisture - old - Walls, Throughout

Water damage is noted on the joists/sills under the north living room wall. We cannot determine if this area is actively leaking or old damage. Monitor.

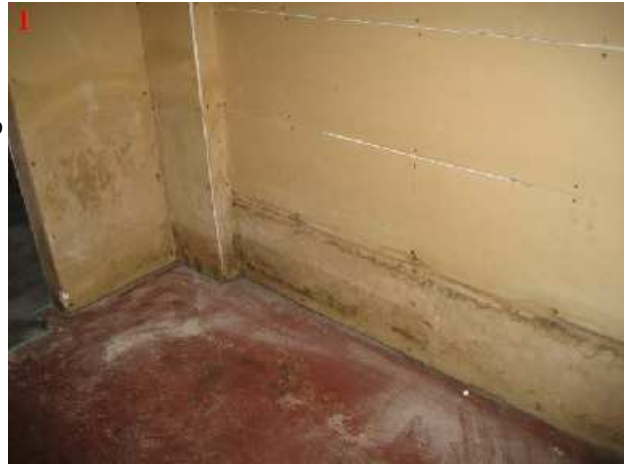
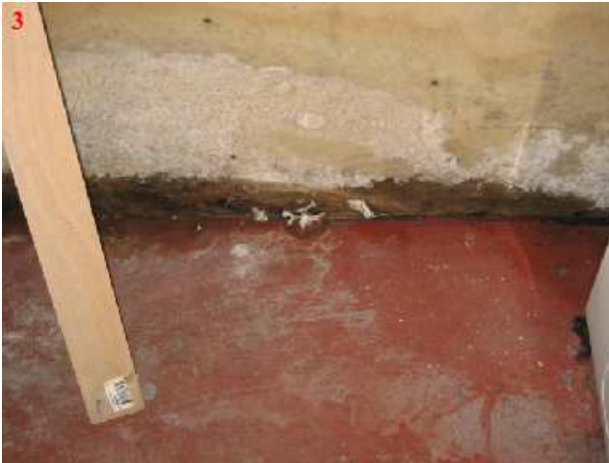
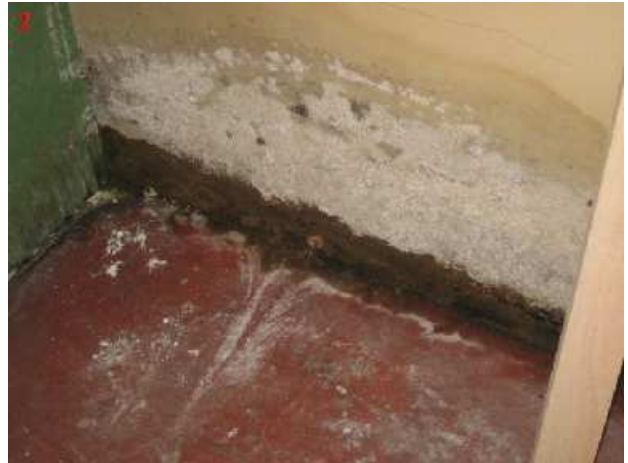
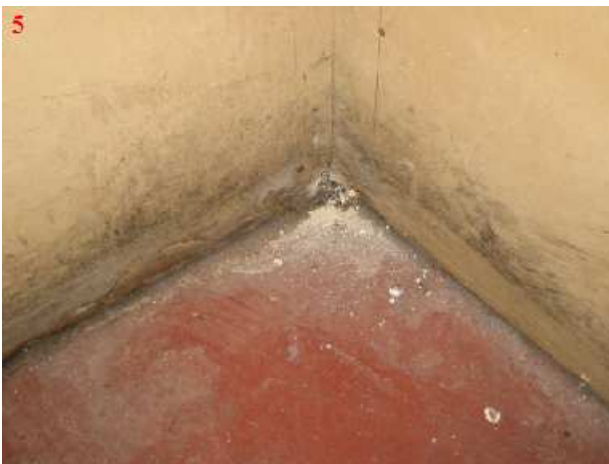
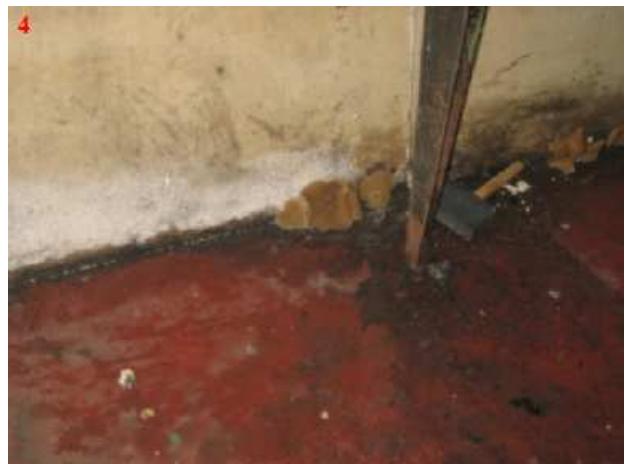
Mold-like substance noted throughout the basement. Some areas also have fungus growing - indicating that moisture issues have been on-going. This substance should be tested and appropriately remediated/removed.

Recommend consulting with a basement water proofing company to determine the best way to prevent water from continuing to enter this basement.

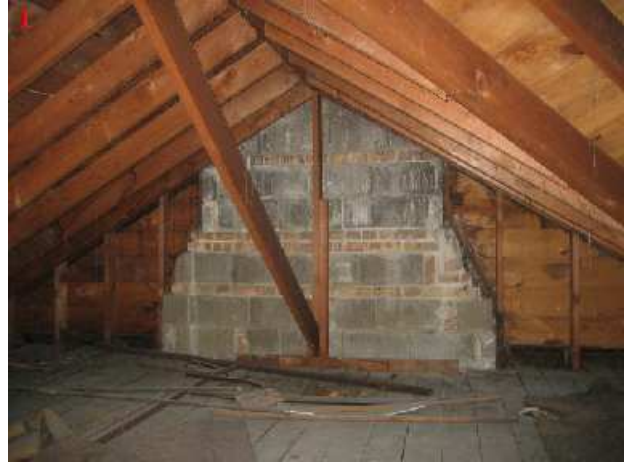
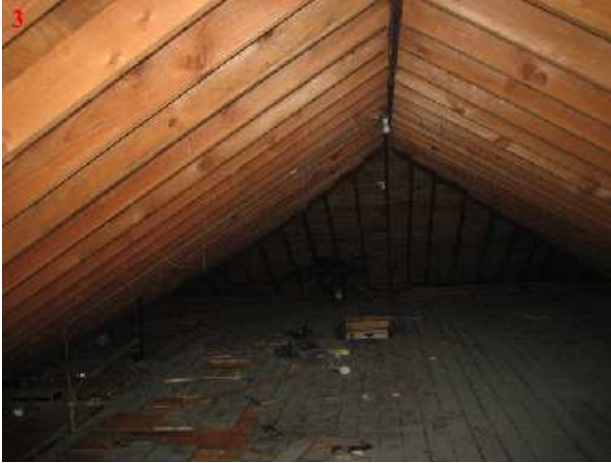
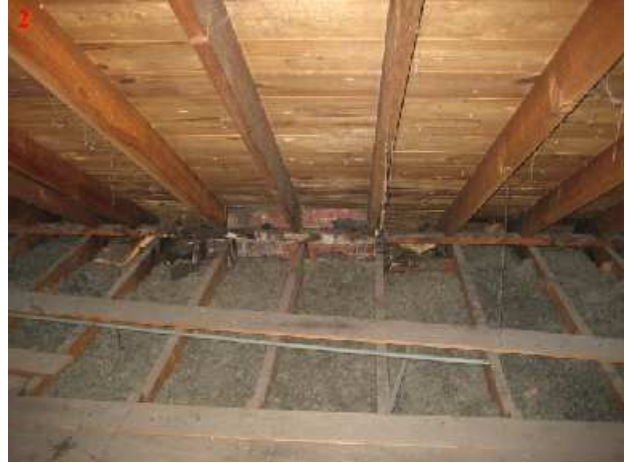
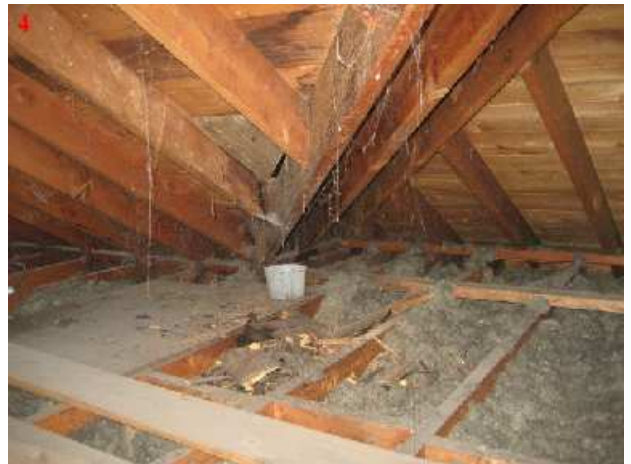
Sat/Minor Repairs ATTIC - General Comment

Photos show general view of attic
There is a lot of water damage on the sub-roof. However since the roof was recently replaced, it appears that this is probably old damage.

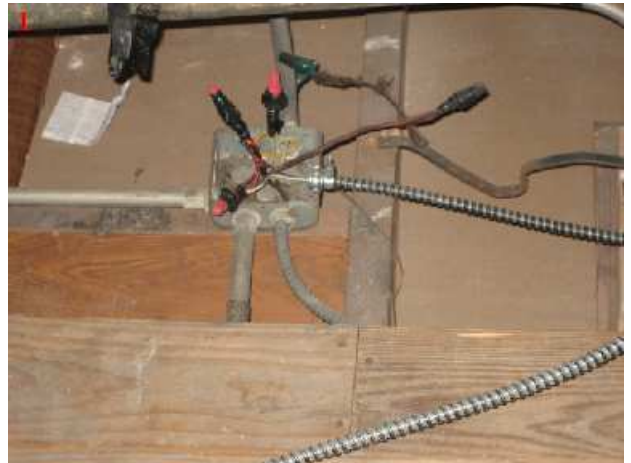
Safety Concern Attic Wiring - Solid metal, Wires exposed

There is exposed wiring in the attic. This is considered a safety hazard and should be corrected by a qualified electrician.
