Inspection, Condo

City Lane

Chicago , IL

Record 20070822a - Inspection, Condo City Lane, Chicago , IL

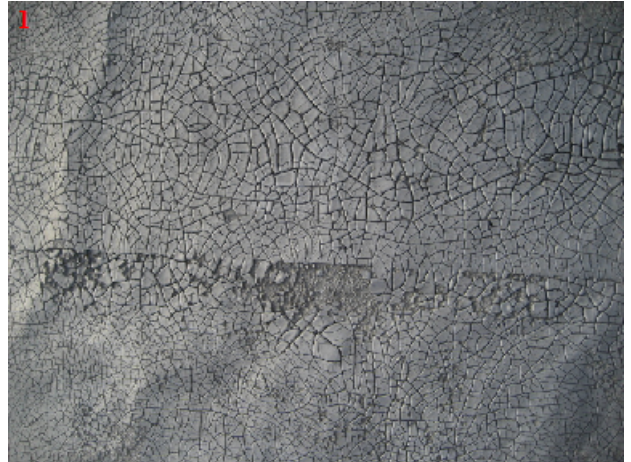
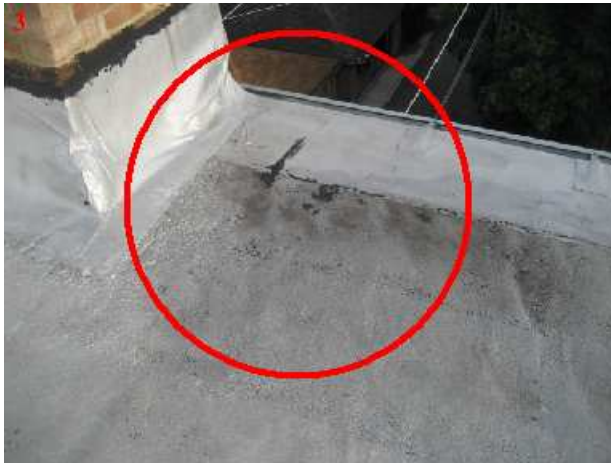
The roof has heavy alligating. Photos 1/2. This indicates that the roof is reaching the end of its useful life. Expect to replace this roof anytime in the next several years.

The roof has heavy alligating. Photos 1/2. This indicates that the roof is reaching the end of its useful life. Expect to replace this roof anytime in the next several years.

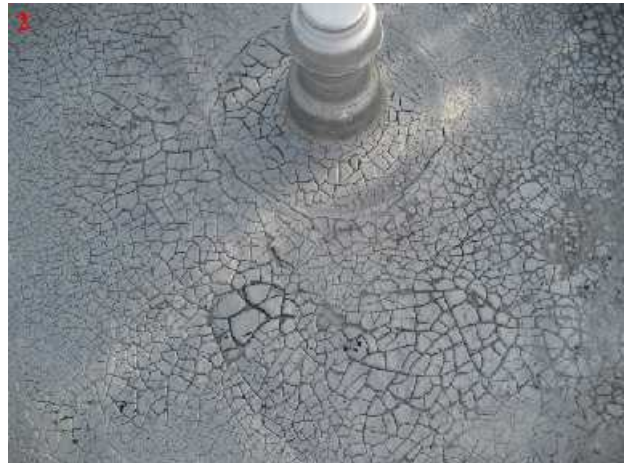
Ponding was noted in the NW corner of the roof over this unit. Re-pitch this area as necessary to allow for proper drainage. Photo 3

Ponding was noted in the NW corner of the roof over this unit. Re-pitch this area as necessary to allow for proper drainage. Photo 3

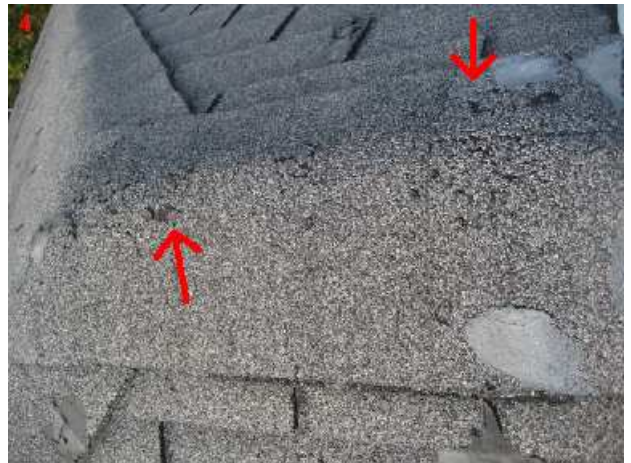
The asphalt shingles on the front gables are also deteriorating. Replace as necessary. Photo 4

The asphalt shingles on the front gables are also deteriorating. Replace as necessary. Photo 4

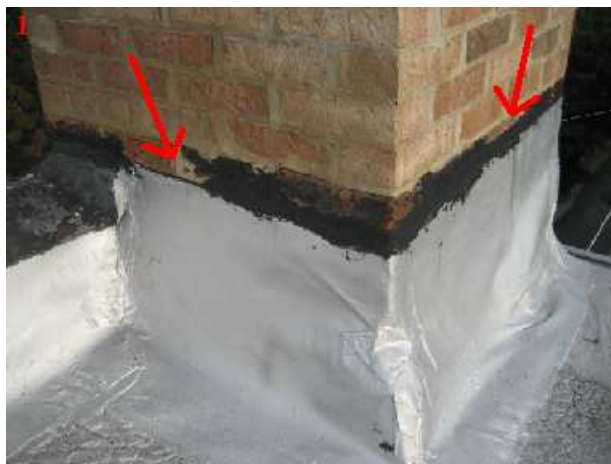
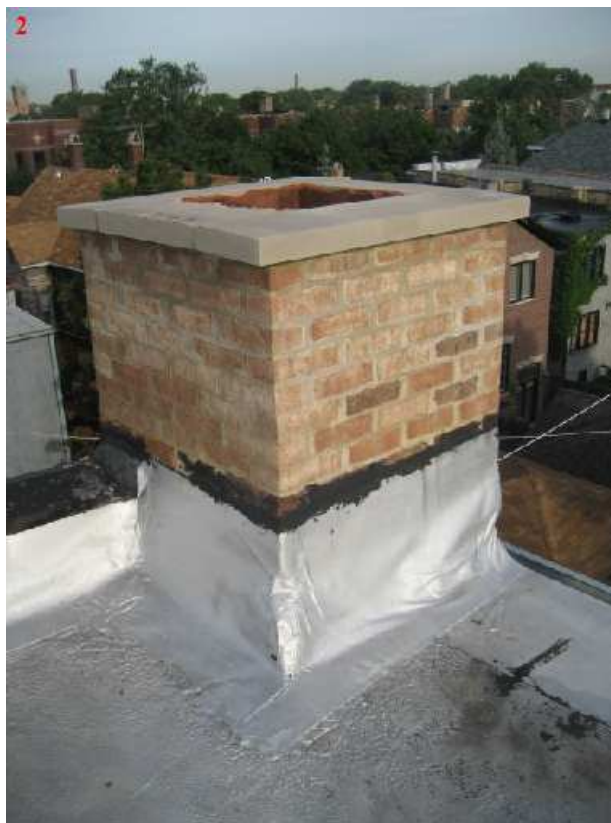
Service/Repair CHIMNEY - General Comment

There is a chimney in the NW corner of the building. The roof is not properly connected to the chimney - add proper termination bars. Additionally, there was no visible flashing under the limestone chimney cap - this may allow water to run down the chimney. There is water on the ceiling of the unit around this chimney. Repair the flashings, cap and masonry on this chimney to prevent water from entering this unit.

There is a chimney in the NW corner of the building. The roof is not properly connected to the chimney - add proper termination bars. Additionally, there was no visible flashing under the limestone chimney cap - this may allow water to run down the chimney.

There is water on the ceiling of the unit around this chimney. Repair the flashings, cap and masonry on this chimney to prevent water from entering this unit.
